CITY OF EAST GRAND FORKS  
ARENA FEASIBILITY STUDY

# APPENDIX

NOVEMBER 2019

## Condition Assessment Report

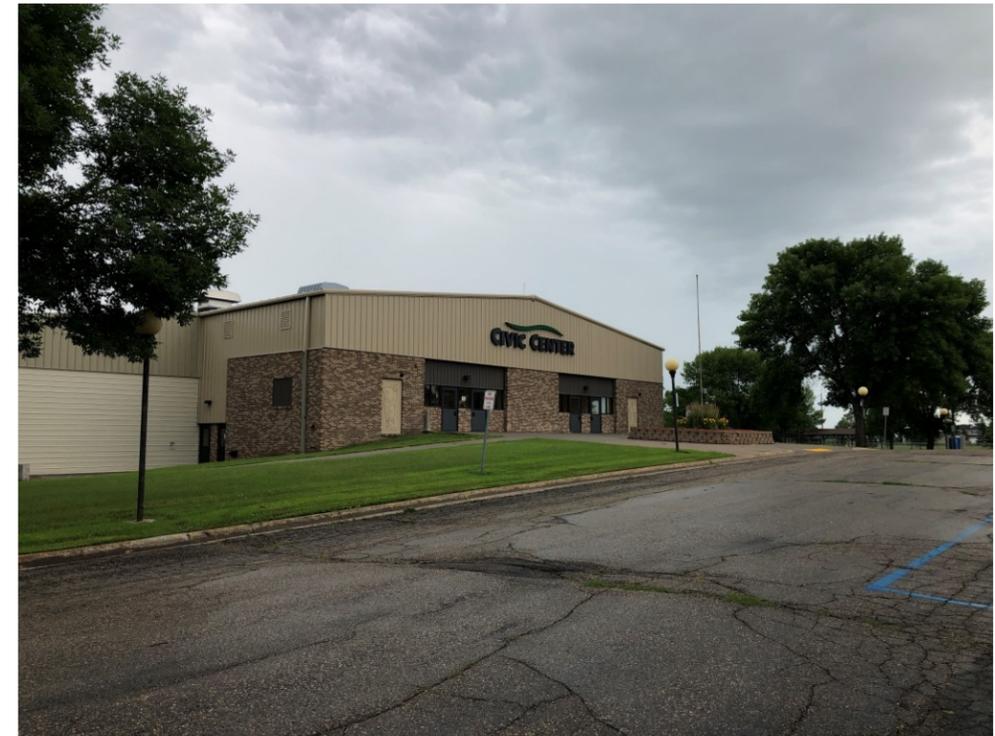
01

Note: Main Building entrance

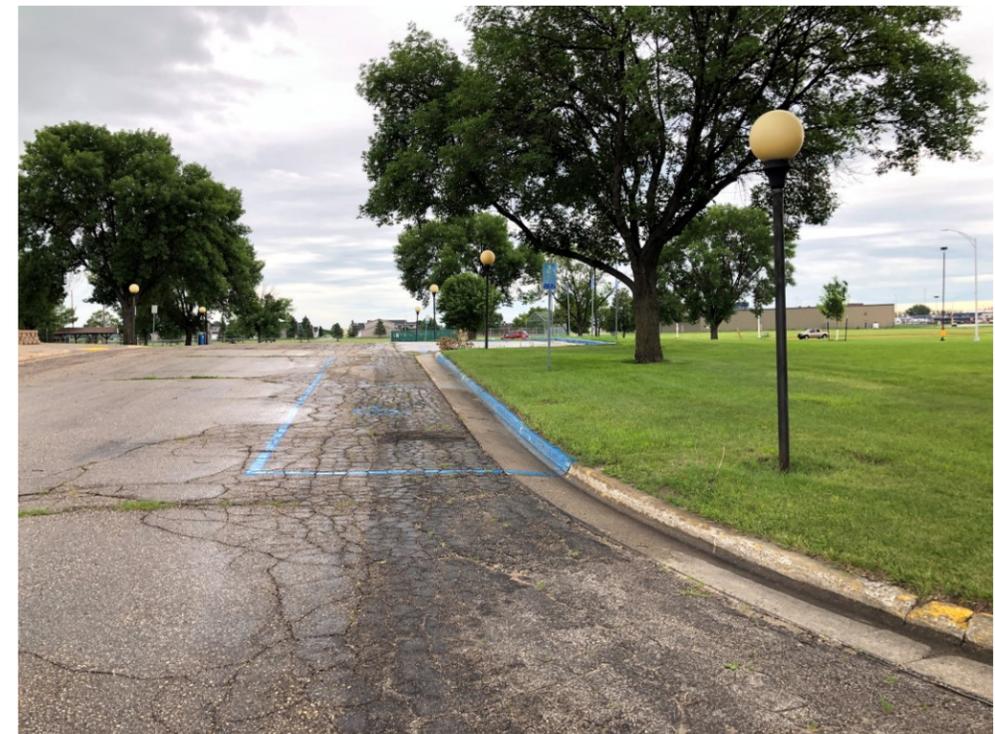
02

Note: Designated Accessible Parking at cross-slope

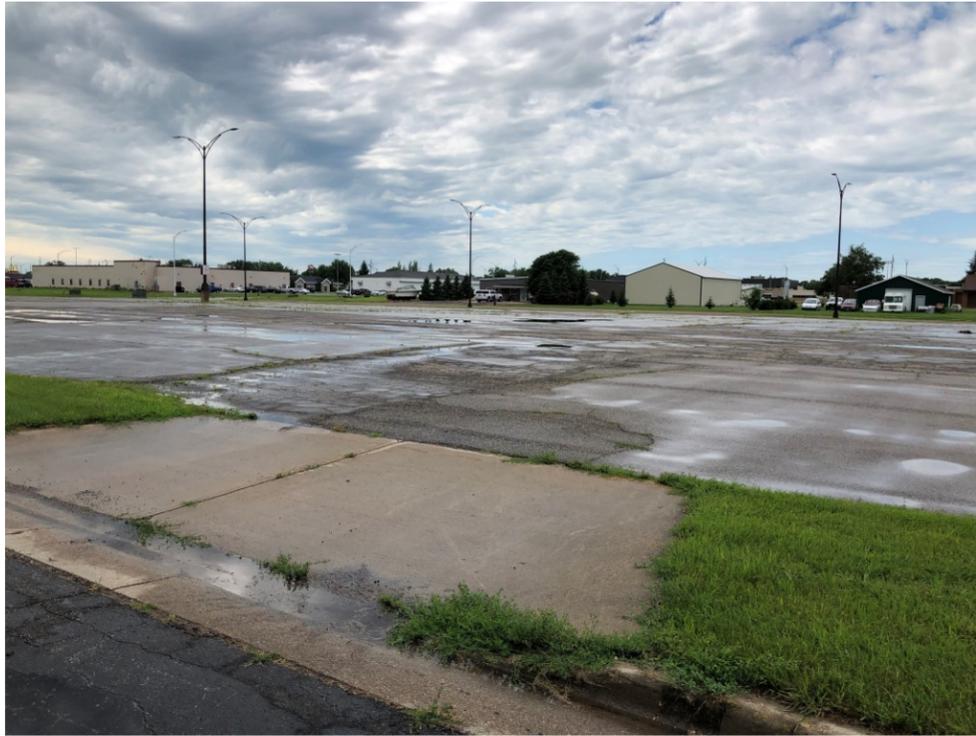
03

Note: Standing water in parking lot after rainfall. Pavement/drainage in poor condition

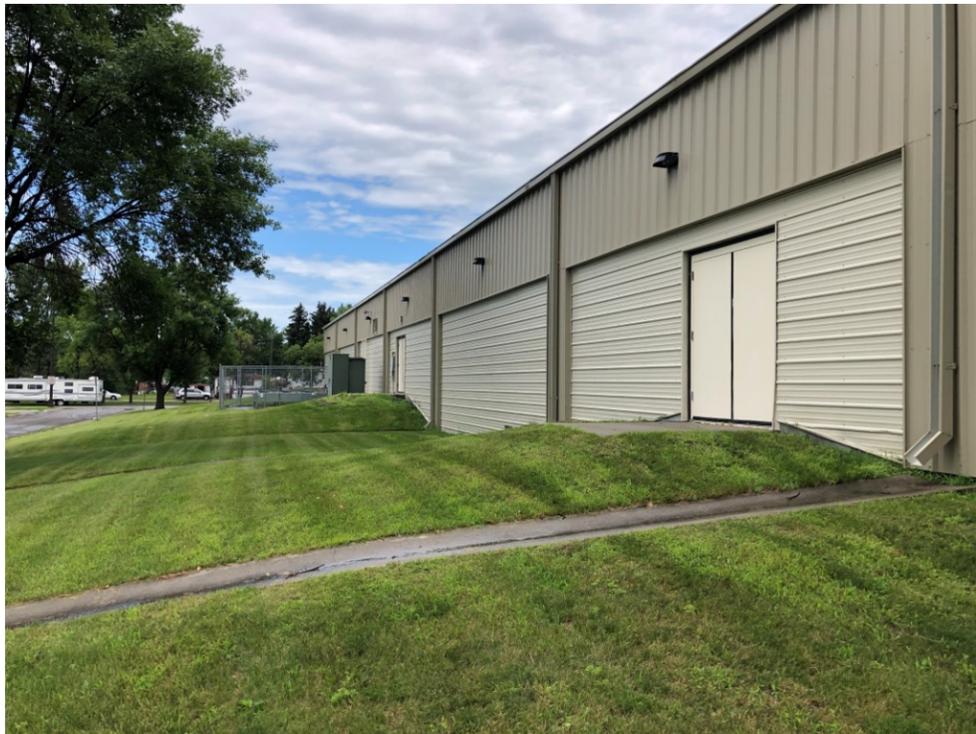
04

Note: Positive drainage around the building

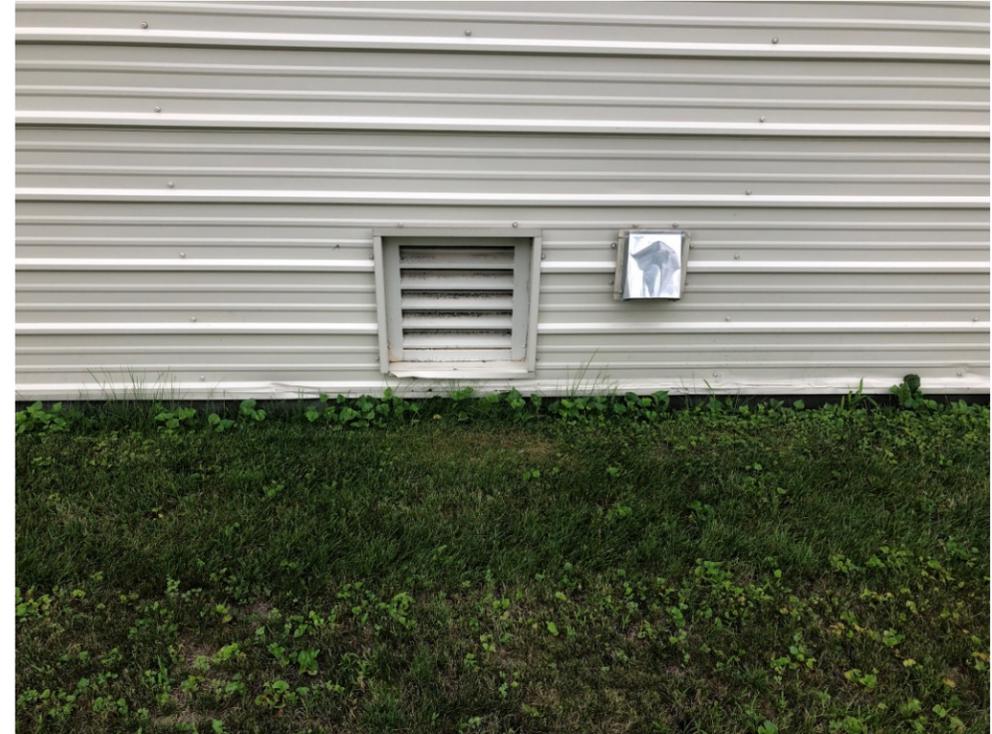
05

Note: Damaged wall panel and trim along bottom of building

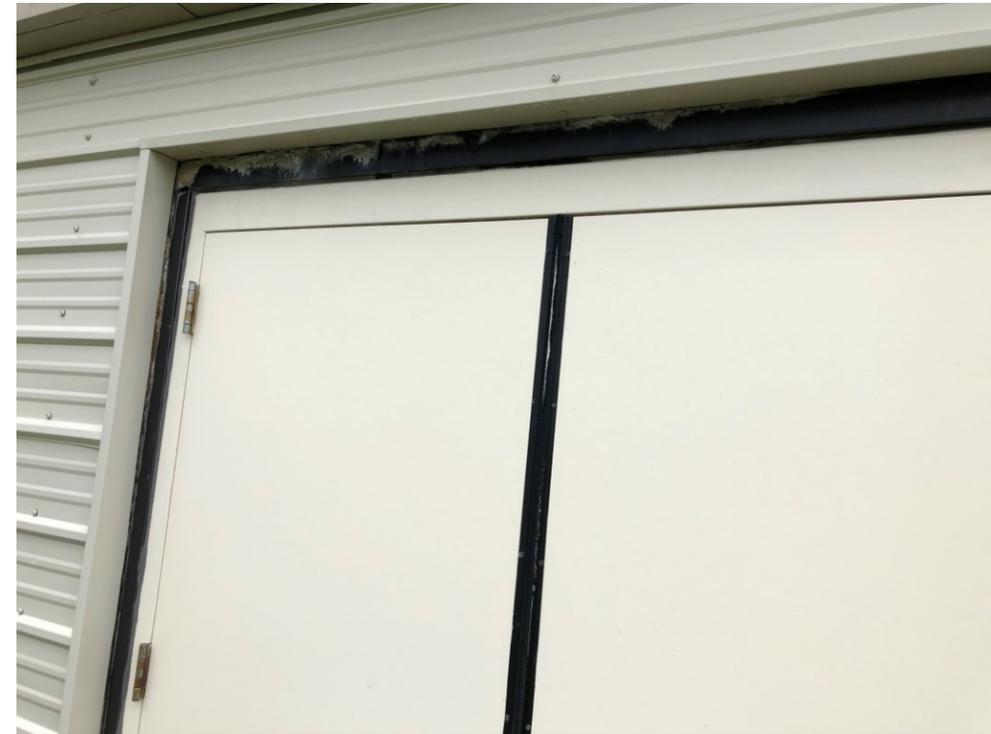
06

Note: Closure trim at NE concourse door shows corrosion from water

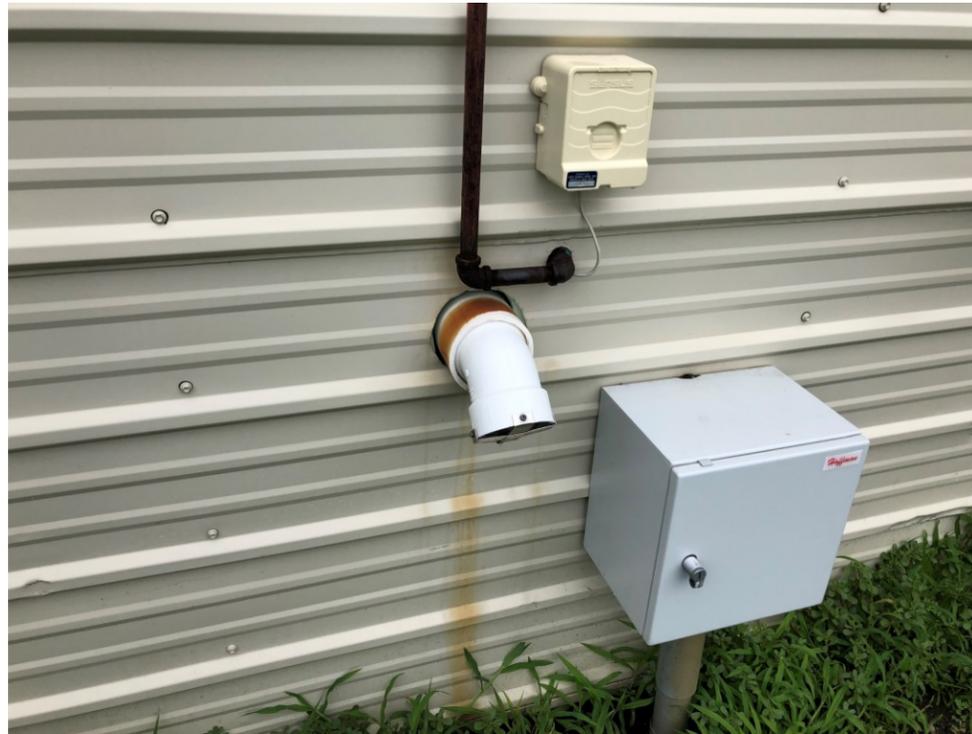
07

Note: Sealant needed around pipe penetration

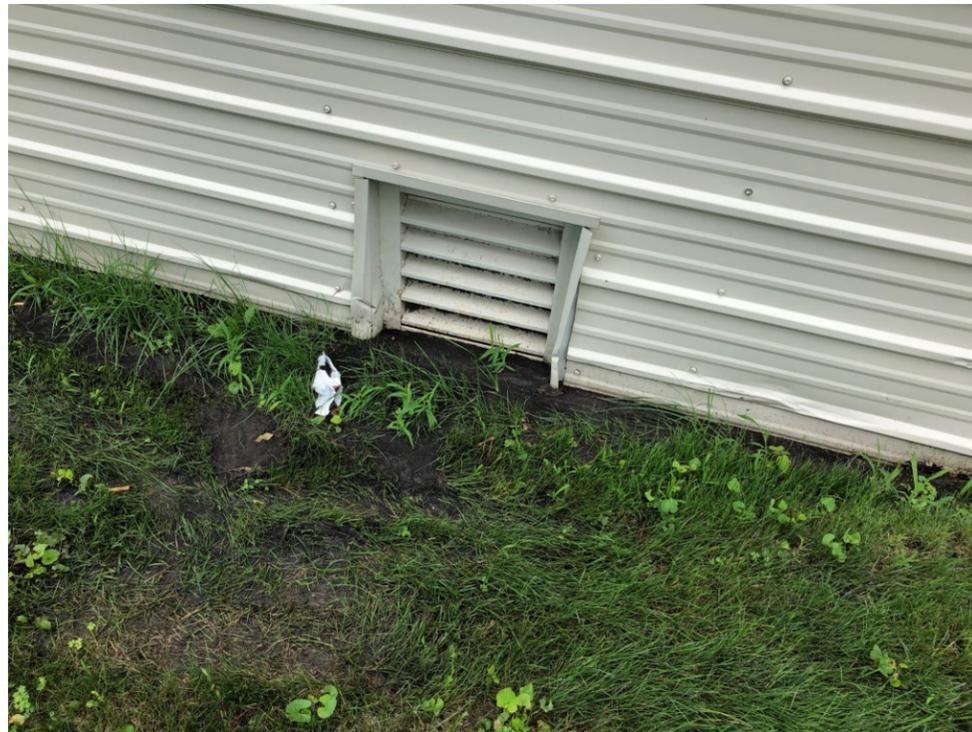
08

Note: Louver at grade can be a potential for water penetration.

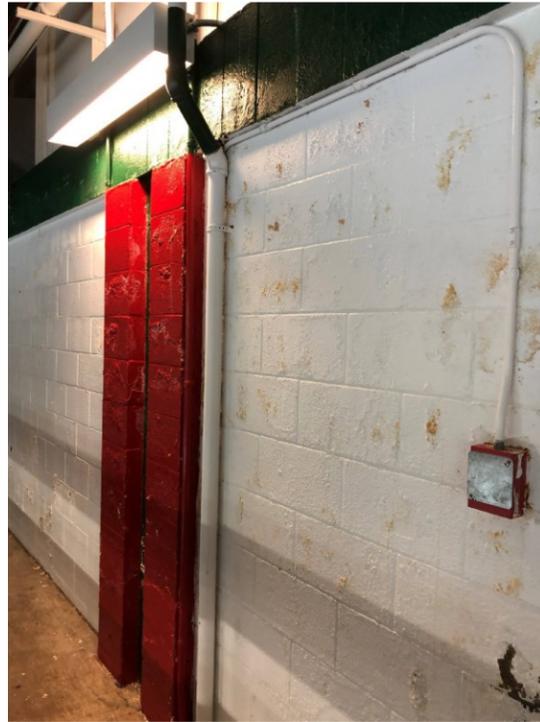
11

Note: Paint bubbling up at exterior wall/column at main level

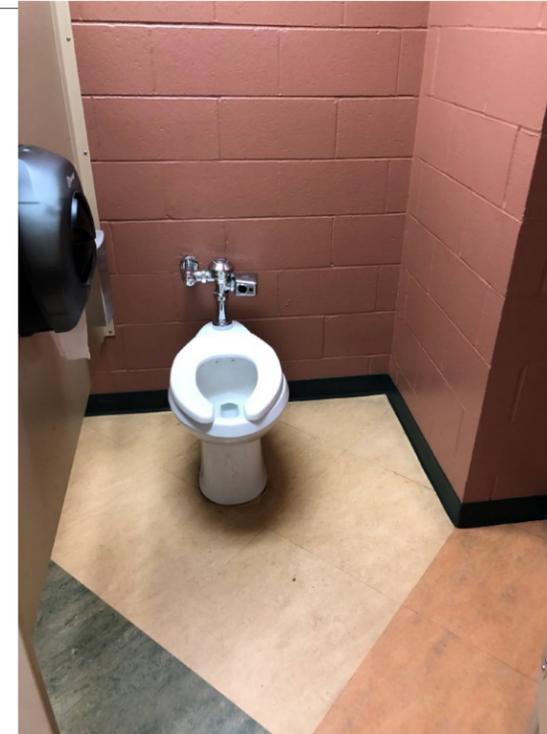
13

Note: No grab bars at north Women's restroom ADA stall. Width is impeded by column in stall.

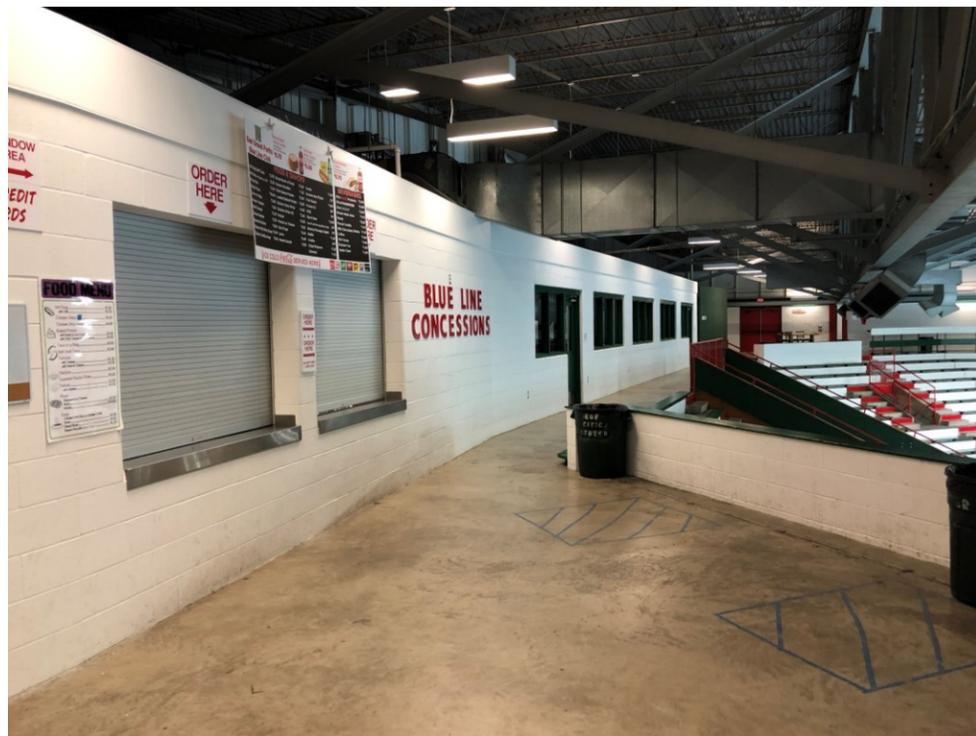
12

Note: No railing behind seating area at north main level, safety concern

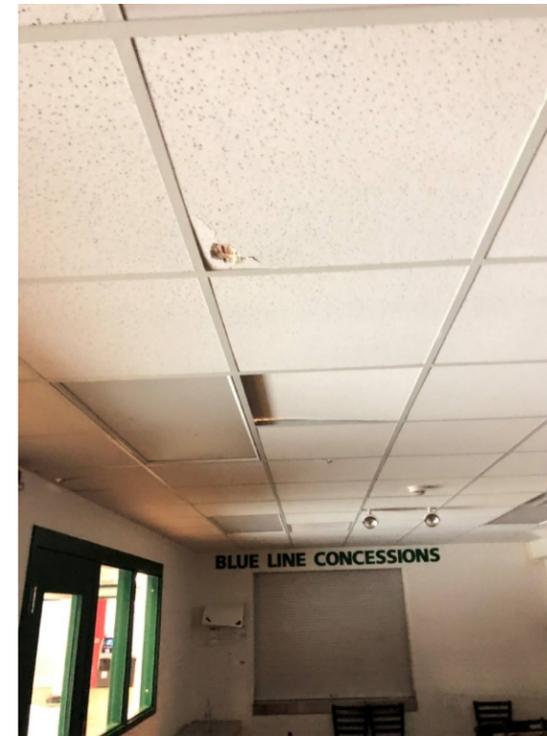
14

Note: Damaged tile at main level concession seating

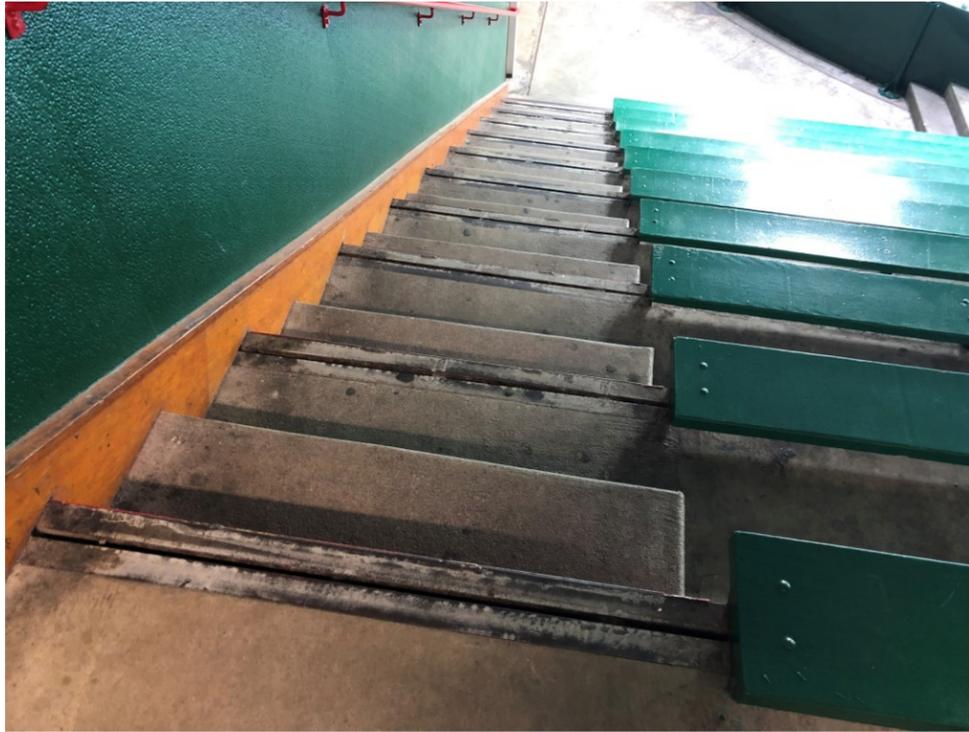
15

Note: Seating aisle steps have steel tread nosing every other step that makes the riser height vary each step. Can be a potential tripping hazard

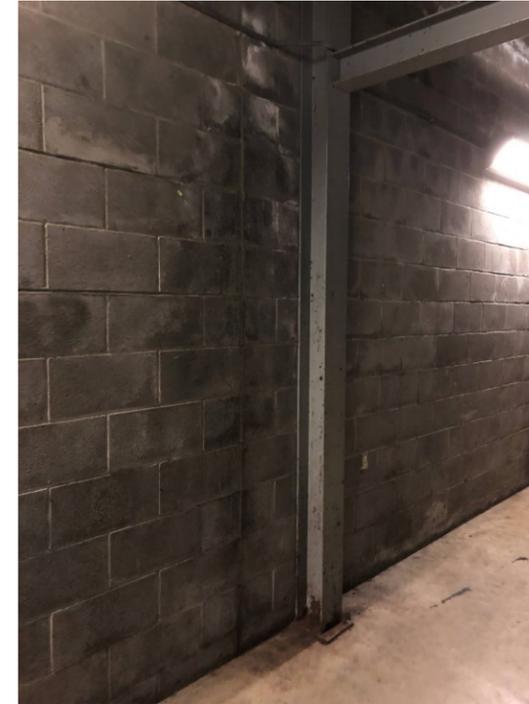
17

To our understanding, the existing CMU walls below exterior grade are exhibiting cracking and inward movement. Upon walking and observing the lower level, Heyer did observe a number of areas along the exterior walls where inward movement of the CMU block has occurred. Steel column braces had been previously installed in select locations to brace the wall from further inward movement. The braces appeared to be structurally working as intended in their area of influence.

The structural issues observed, bowing walls and crack pattern exhibited, are not unusual for CMU walls retaining soil. It is Heyer's opinion that the inward bowing is being caused by the lateral pressure of the embanked soil against the lower level CMU walls. Heyer assumes that native clayey soils were used in the backfill of the wall. Clayey soils tend to absorb moisture more than granular fills and as such swell under wet

conditions causing lateral pressure on retaining walls. However, some small amount of lateral deflection of the CMU wall should be expected considering the consistent soil load against the wall.

Note: West exterior wall below seating has bowed in over years, additional structural column and beam to support it. Some water damage is visible.

Heyer also recommend monitoring of all lower level walls for continued movement. In areas, where excessive bowing in of the CMU walls are observed (~1" or more), Heyer recommends installing column braces, similar to what has been previously installed in other areas. Design of the type and number of column braces is beyond the scope of this report, but Heyer would be happy to assist in the preparation of that design. Another supplemental remediation measure that could also be utilized would be to excavate the backfilled soils adjacent to the structure and install a free draining granular material. If the current soils are clay, the replacement free draining granular material would not hold as much moisture and more rapidly move ground water to the buildings sump system. Reducing the moisture in the soil would lessen the lateral pressure against the walls.

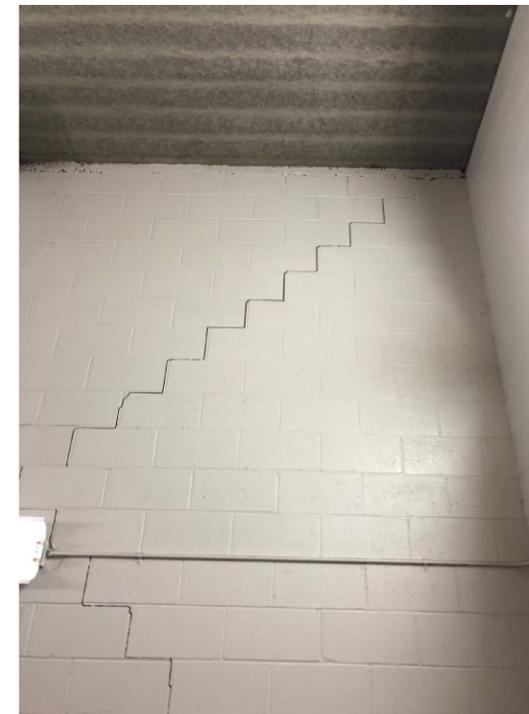
18

Note: East players' entrance addition has major cracking in the exterior bearing wall.

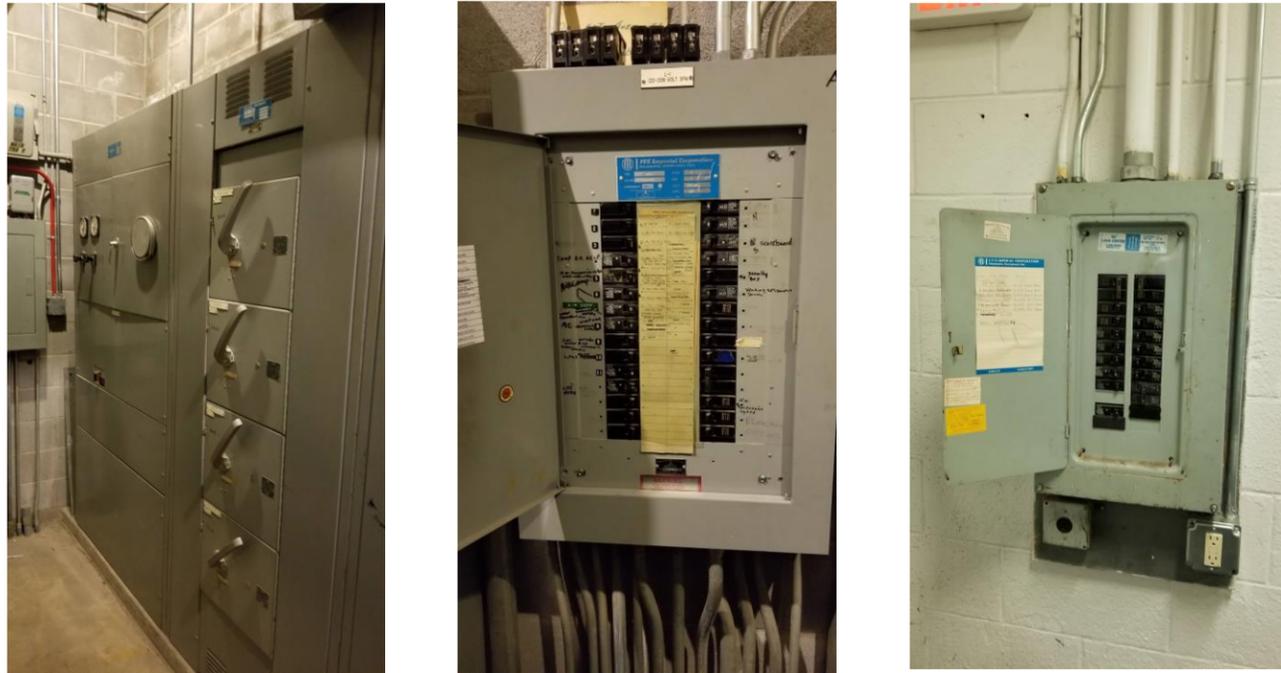
19

- B. All electrical distribution equipment is original to the area that it serves. Most panels are beyond expected life and are due for replacement.
  - C. In the main service room there is a panel that is tapped from the incoming service conductors that originally served as an emergency power panel. This method of providing emergency power is not longer valid and the panel would no longer be considered emergency power (see emergency lighting notes).

Note: Original Switchgear and Panelboards are past expected life.

- G. Recommendations:**
- 1. Aged existing electrical equipment and associated feeders should be placed on a schedule for upgrade.
    - a. Cost: \$200,000 (these upgrades could be absorbed by other renovation or expansion projects)

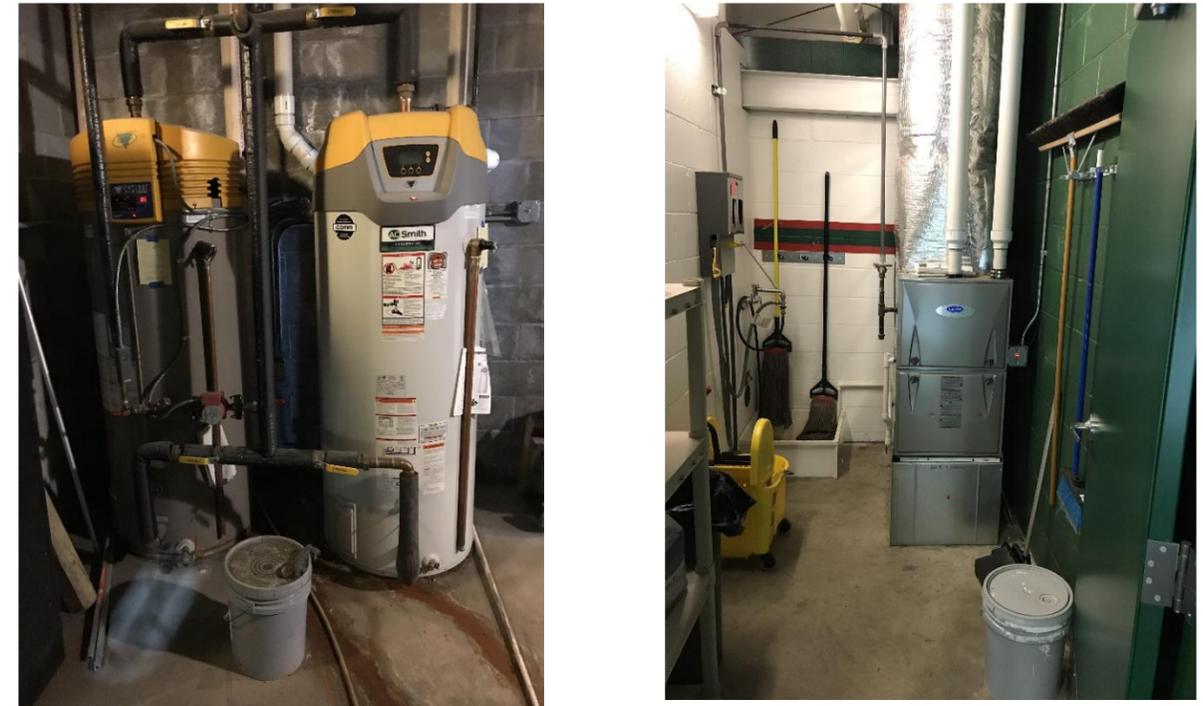
21

- A. The two main water heaters are natural gas fired units and are located in the lower level Storage 148 area. One water heater was manufactured in 1997, is now 22 years old and is past its useful life. The other water heater was installed in 2011 and is still in good condition. A recirculating pump system is installed for these water heaters and serves a portion of the building. Additional electric hot water heaters installed in 2015 at concessions areas at either end of the building. These water heaters are in good condition.

Note: 1997 Water Heater (Left)

Note: Typical natural gas furnace serving auxiliary spaces. Many install in 2006 with no cooling.

1. The 1997 water heater should be replaced with new. The rest of the existing water heaters are in good condition and should remain.
  - a. Cost: \$20,000
2. During remodel, any old plumbing fixture should be replaced with new as well as ASSE 1070 rated thermostatic mixing valves being provided to protect against scalding. The architect will need to determine the requirements to meet current ADA standards for the toilet room layout.
  - a. Cost: \$5,000 per plumbing fixture

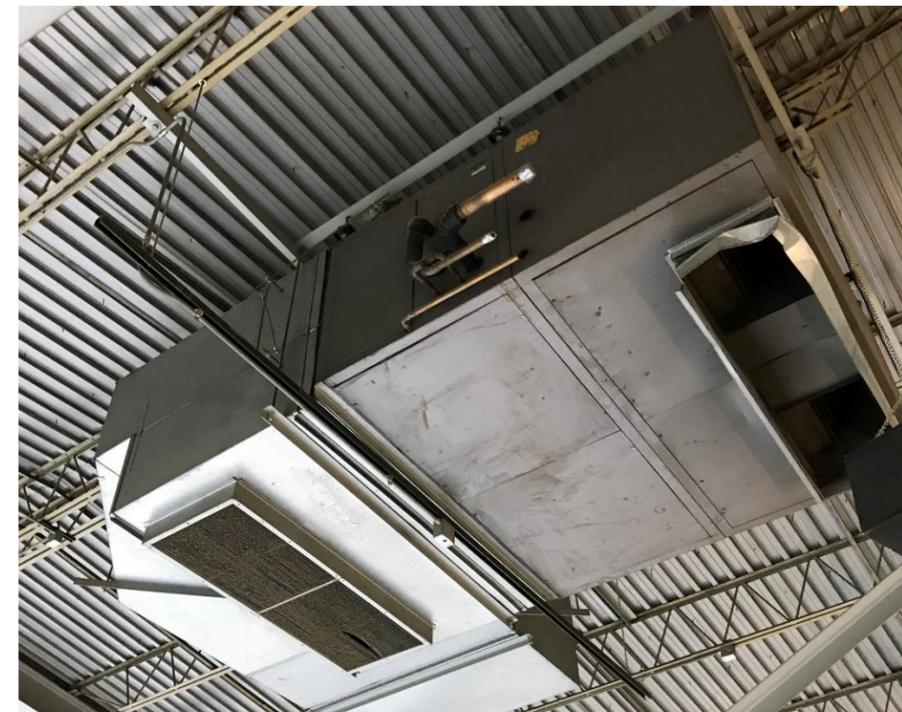
22

- B. An air handling unit with a cooling coil is located in the space but no refrigerant lines or condensing unit are installed.
- C. Concessions areas are provided with gas fired furnaces. These units do not have air conditioning installed. Exhaust is being provided from each of the concessions areas. These furnaces are new and in good operating shape.

Note: Air Conditioning Unit Serving Bowl. Refrigerant coil not connected to any condensing unit.

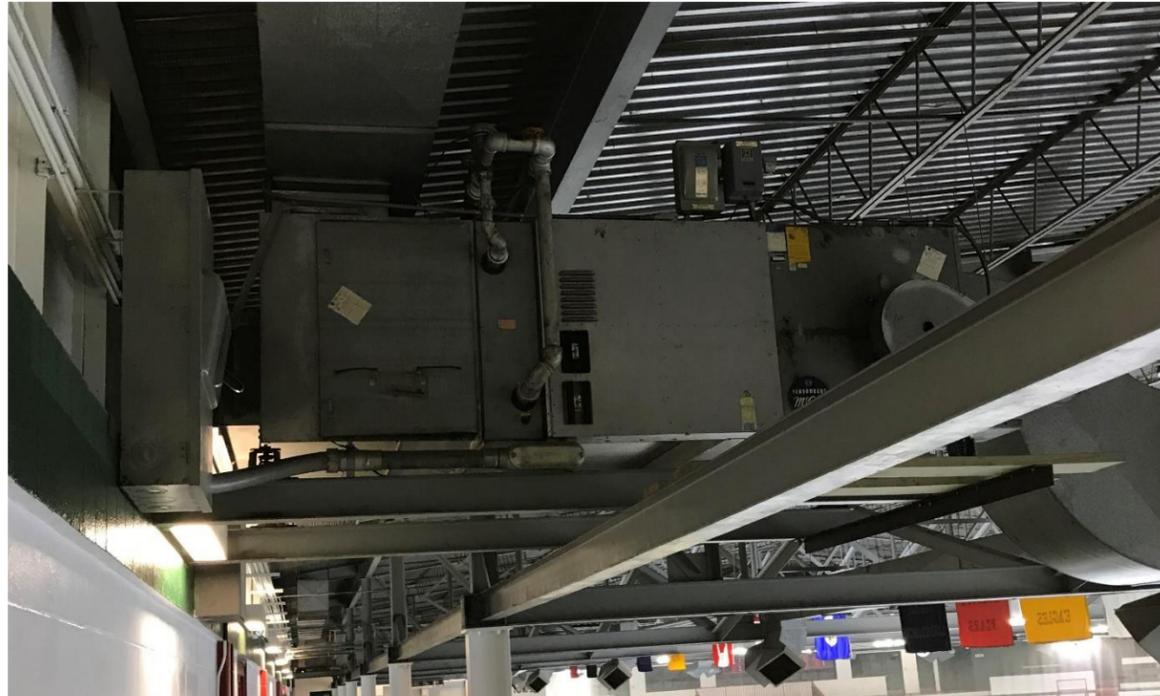
- A. The ice rink has multiple dedicated air handling units around the perimeter of the space to provide ventilation to the rink. Power roof mounted relief fans and roof hoods are located on one end of the rink to relieve air. The units are equipment with waste heat coils from the ice refrigeration system as well as electric heating coils. These units do not have air conditioning and are original to the ice arena. Two of the units are currently not operational and the rest of the units are past their useful life.

Note: Typical air handling unit serving bowl original to building. Electric heat with no cooling.

- a. Cost: \$400,000
2. Replace air handling units in ice arena with new units. Existing units are beyond useful life and starting to fail. Basis for new units would be hot water heat with DX cooling to condition the space. Units would be sized to handle the ventilation required in the hockey rink.

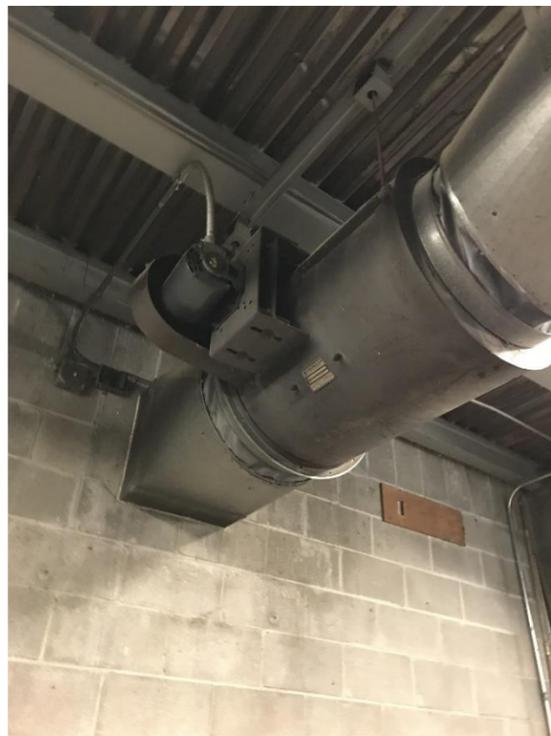
23

- E. Some lower level exhaust fans are original to the building are reaching the end of their useful life.
- F. Air conditioning is not installed in the building with the exception of a weight room on the east side of the building. The furnace and condensing unit for this space is still operating but is approaching the end of its useful life.

Note: Typical exhaust fan. Original to building.

- a. Cost: \$450,000
4. Lower level exhaust fans are at the ends of their useful life. New exhaust fans should be provided to replace existing original exhaust fans as they fail.

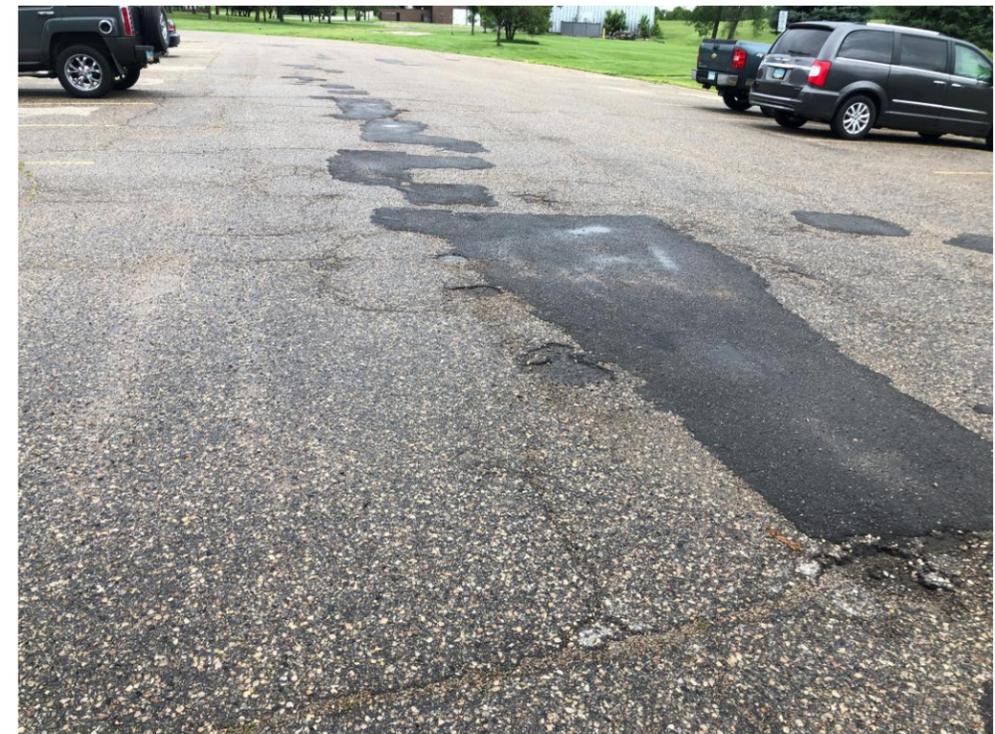
02

Note: Condition of parking lot paving is below average

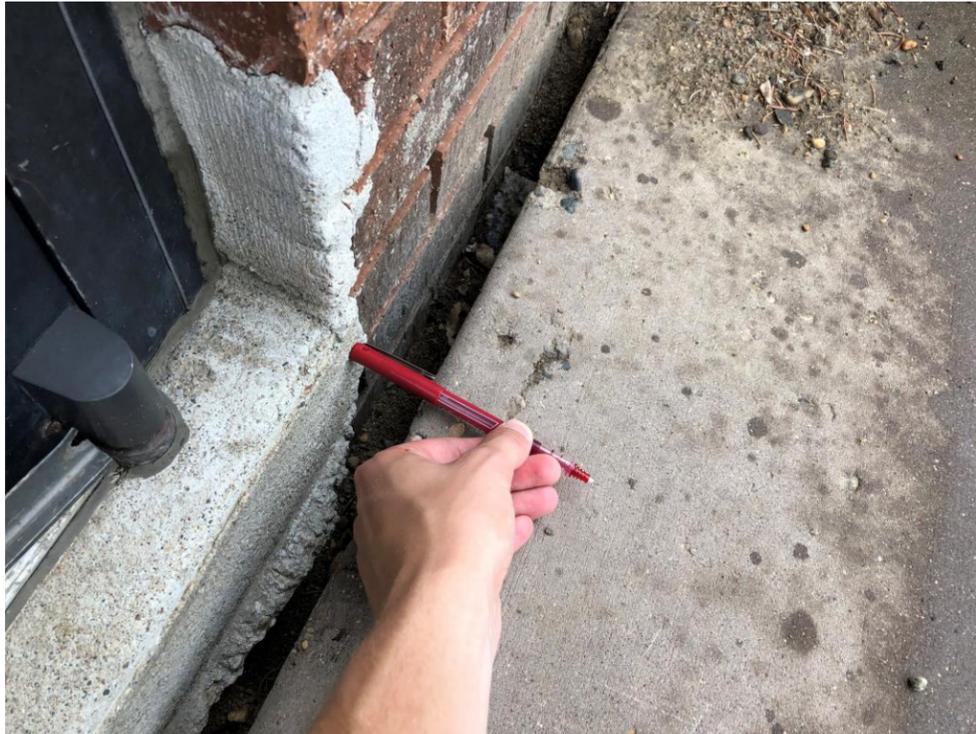
03

Note: Concrete path has settled away from building entrance doors (no stoops)

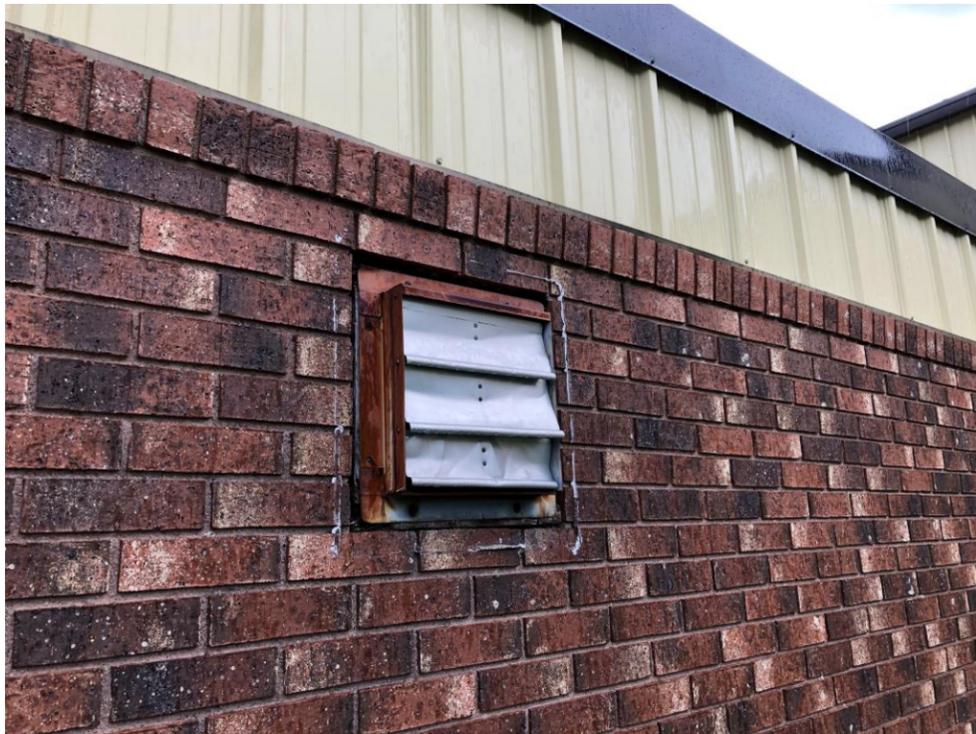
04

Note: Missing trim around mechanical louver

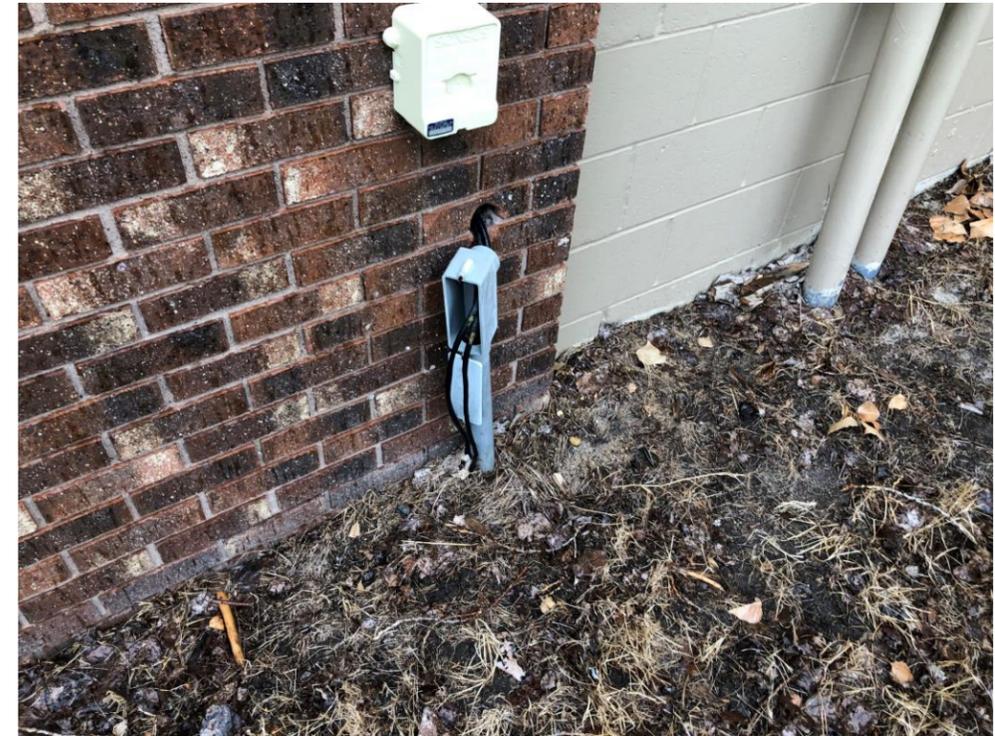
05

Note: Sealant needed around wall penetration

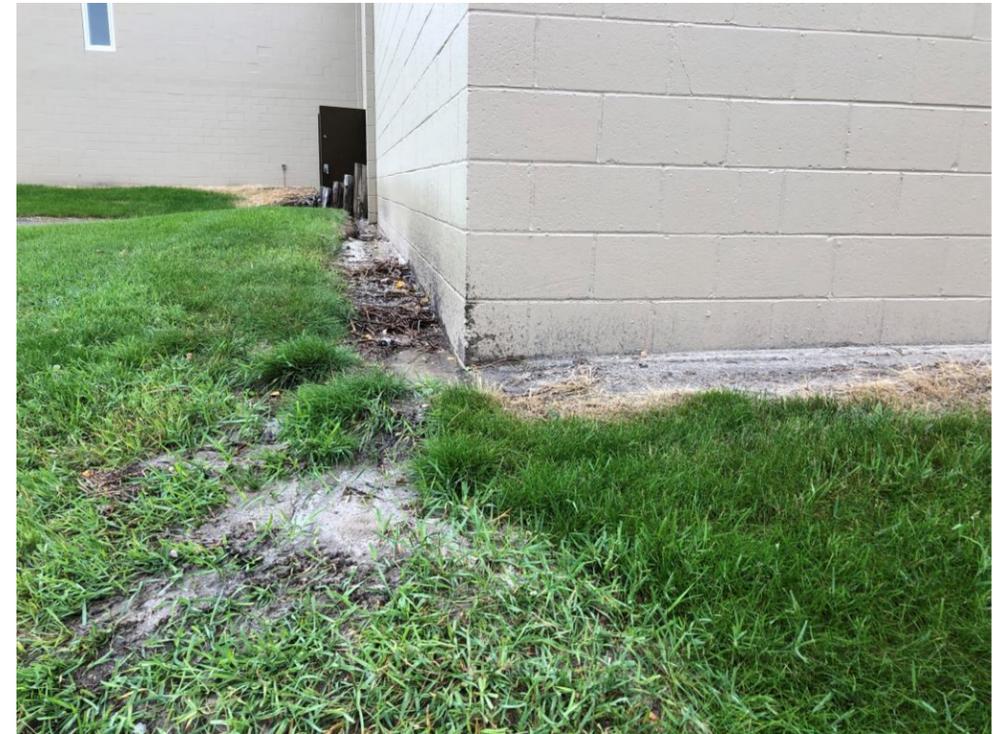
06

Note: Uncontrolled water has eroded soil creating backslope toward building, especially at north and west faces.

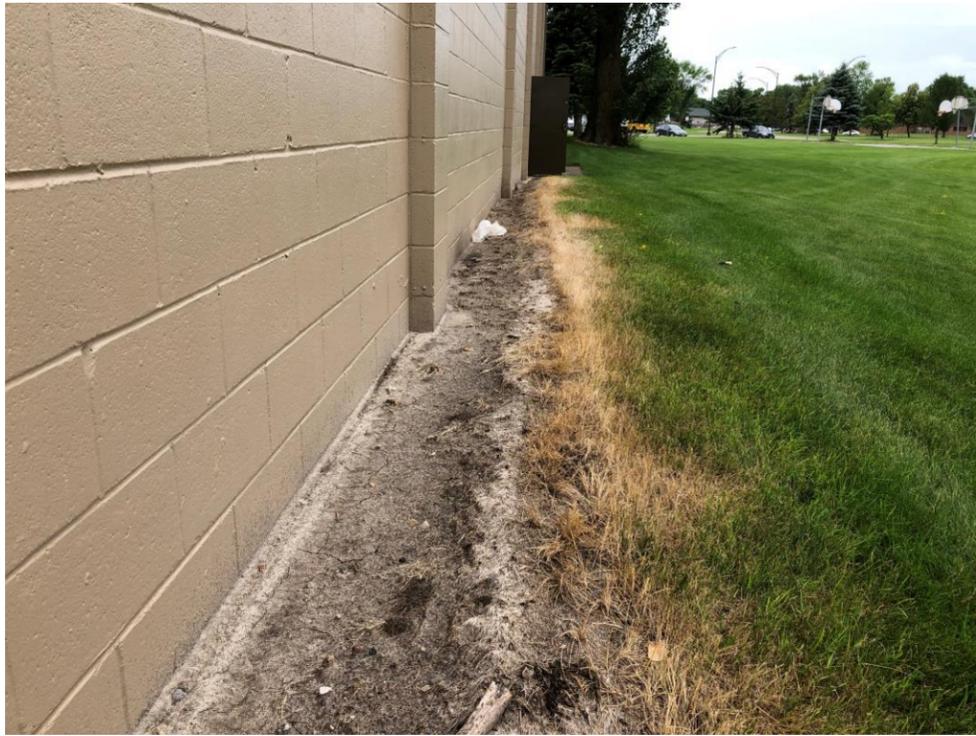
07

Note: Eroded soil at west building face

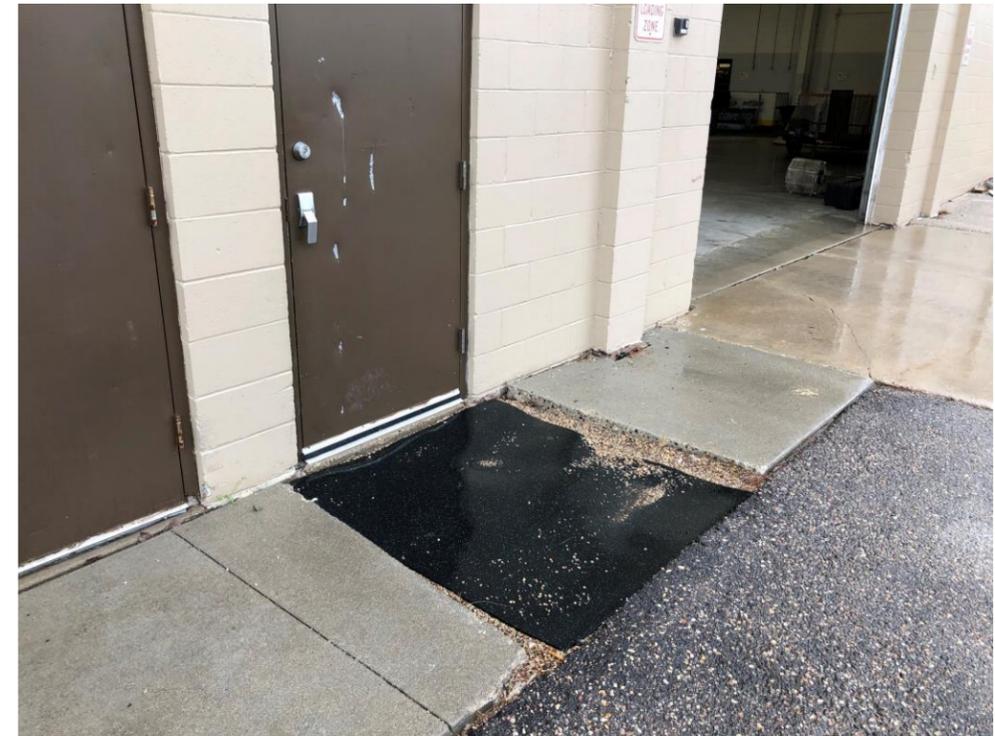
09

Note: Missing stoop and damaged doors, east face

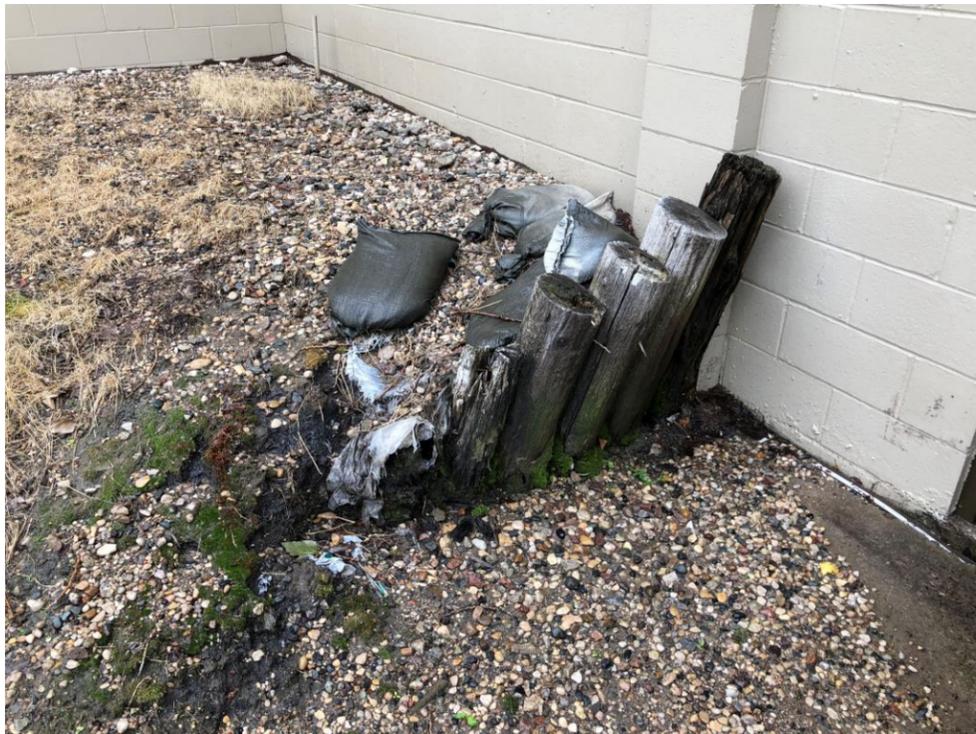
08

Note: Failing retaining wall near northwest corner

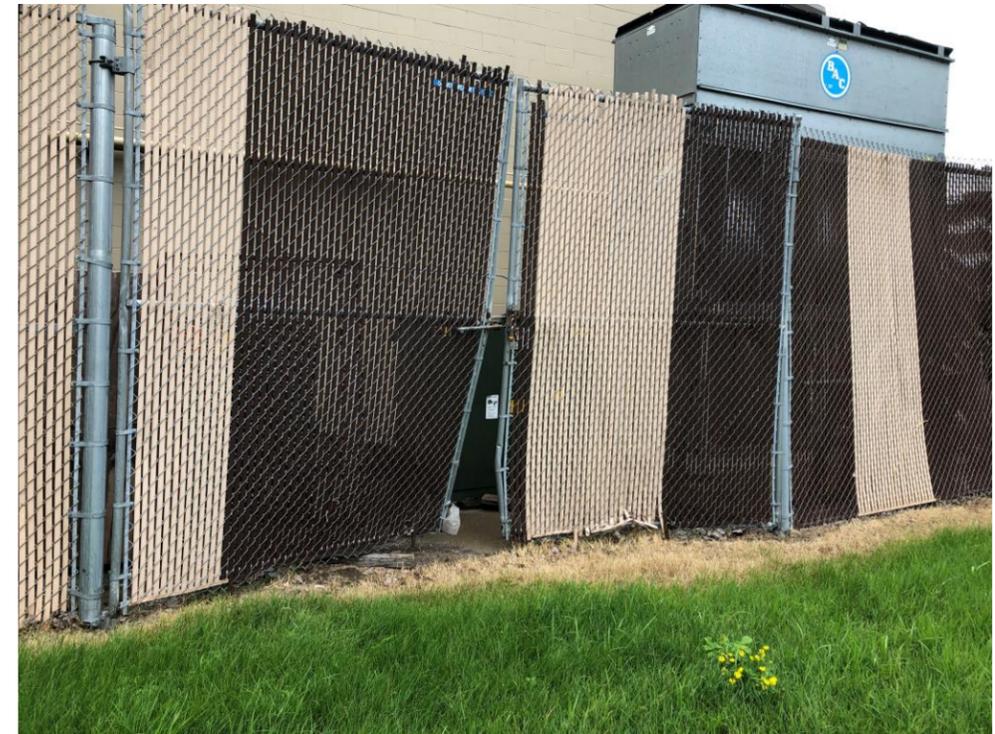
10

Note: Damaged fence and gate

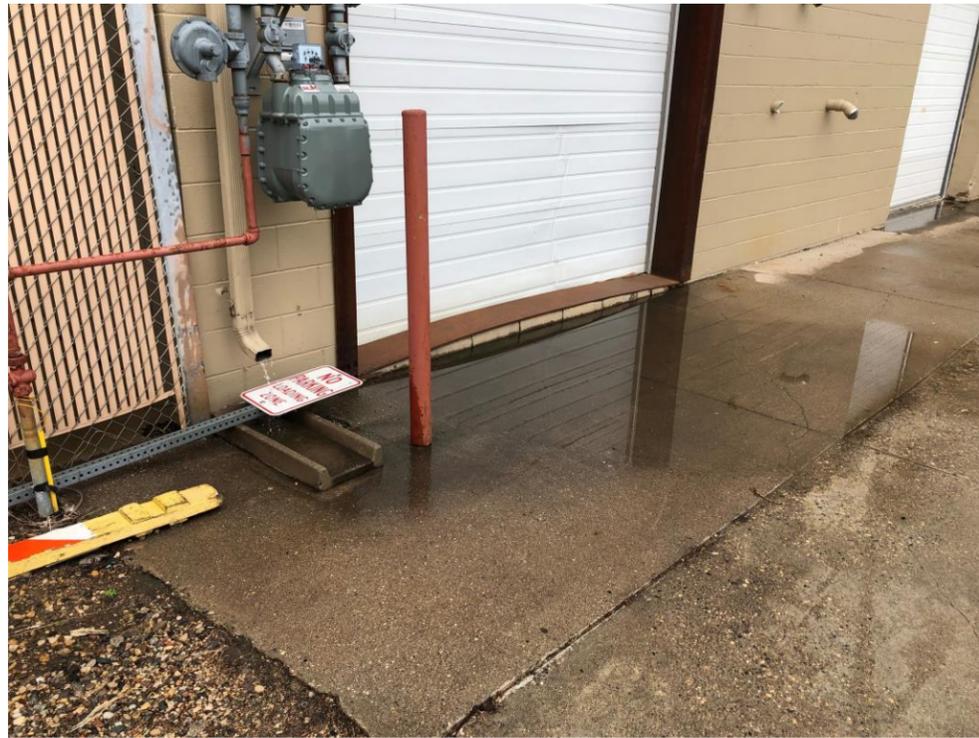
11

Note: Pooling water at exterior of mechanical and Zamboni rooms

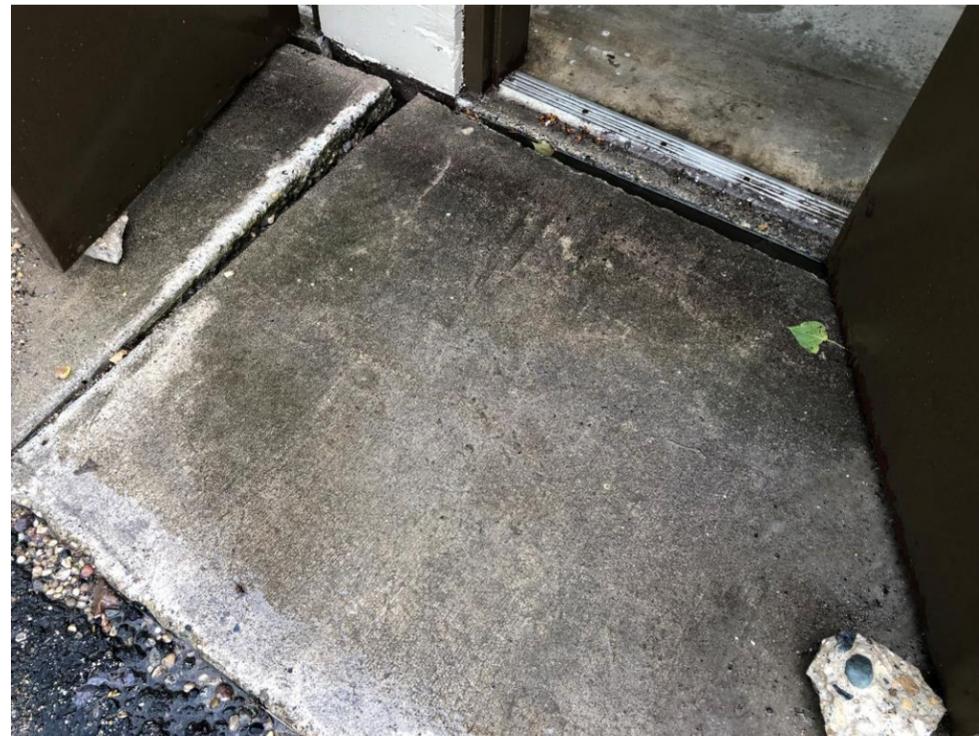
12

Note: Waterlogged concrete heaves in winter and interferes with egress doors.
