CITY OF EAST GRAND FORKS  
ARENA FEASIBILITY STUDY

# APPENDIX

NOVEMBER 2019

## Condition Assessment Report

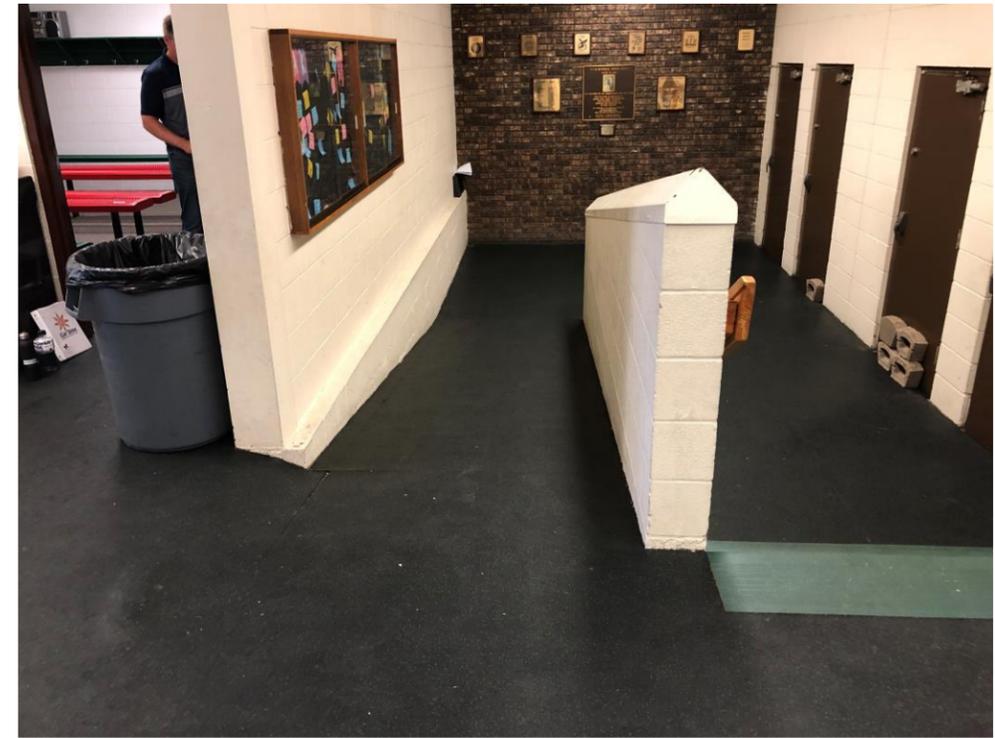
13

Note: Ramp to game level exceeds allowable slope; no handrails.

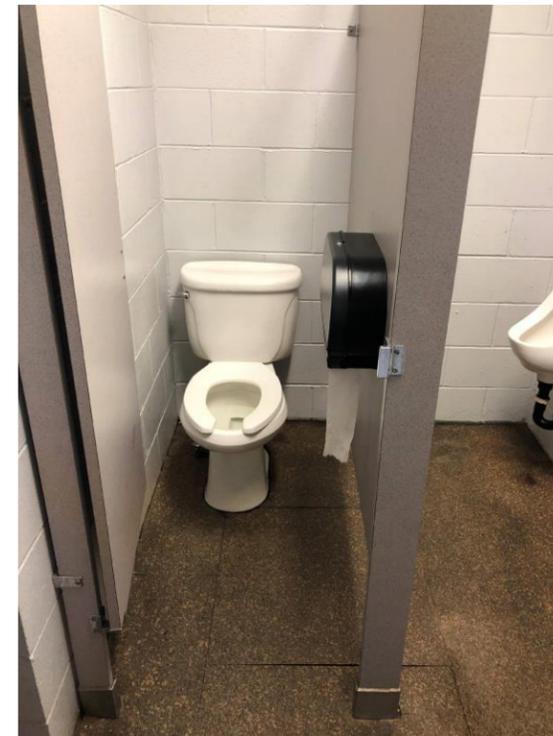
14

Note: Porous flooring in Lobby restrooms.

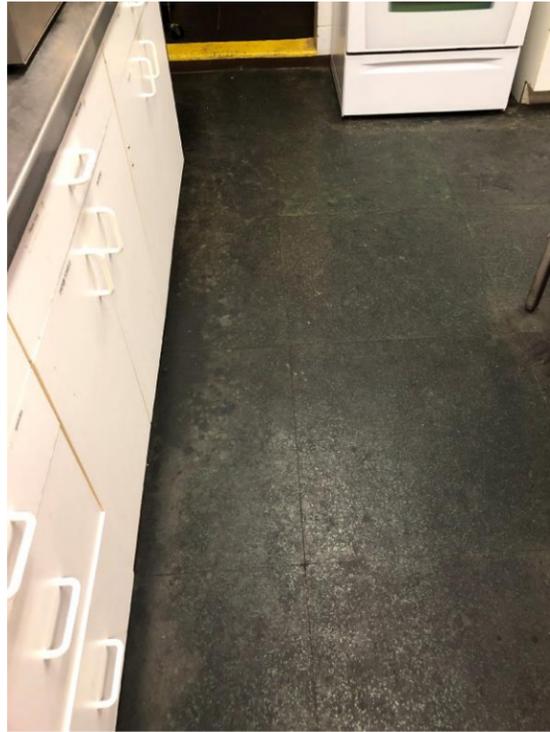
15

Note: Porous flooring in Lobby Concessions

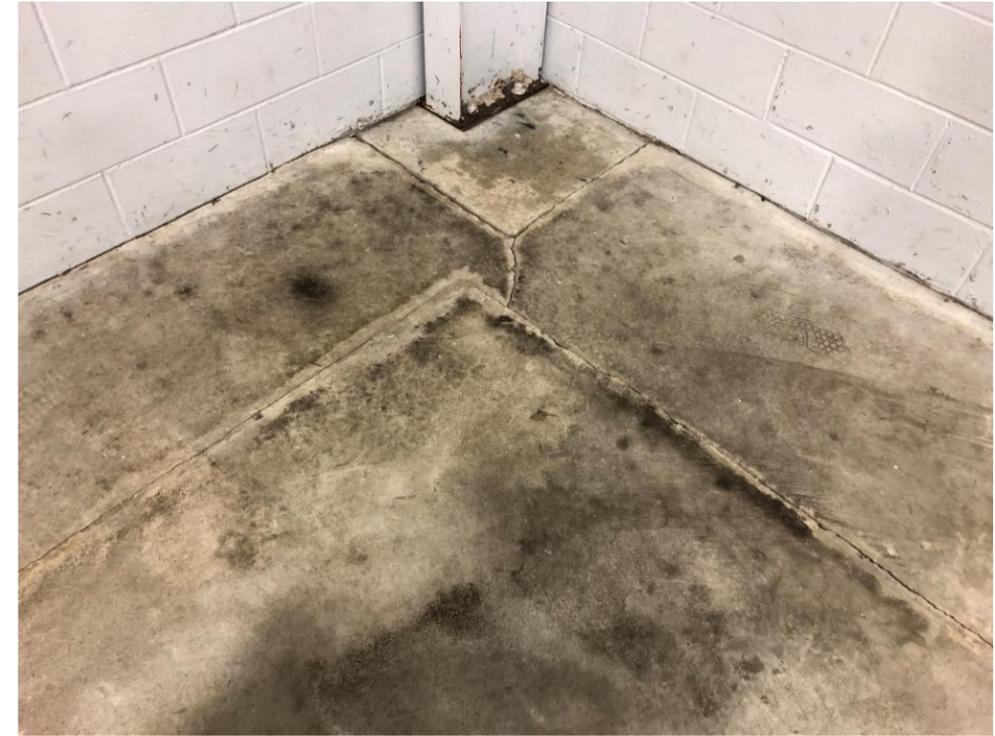
17

Note: Water is infiltrating the concourse, likely due to soil erosion, and pooling causing mold.

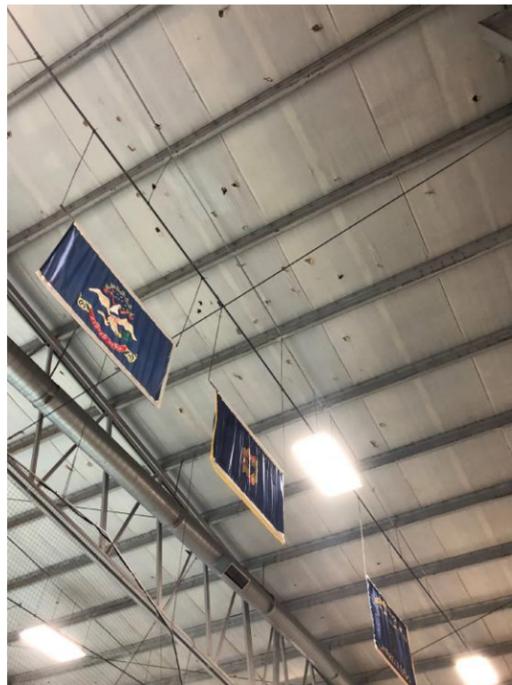
16

Note: Errant pucks have damaged the roof insulation.

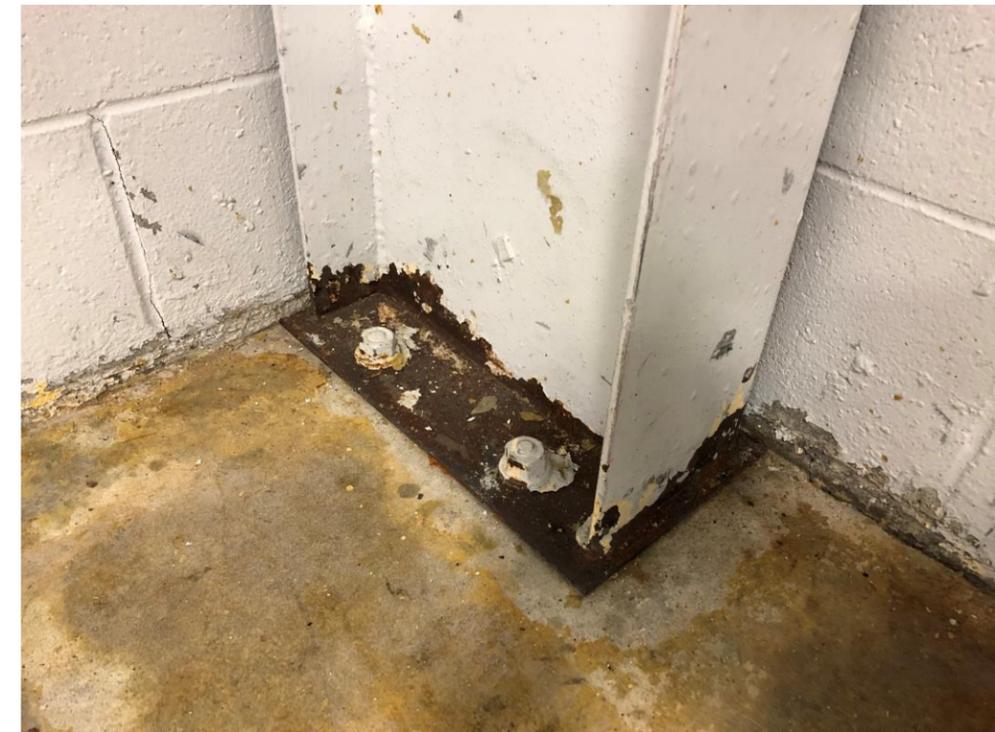
18

Note: Evidence of water infiltration at concourse.

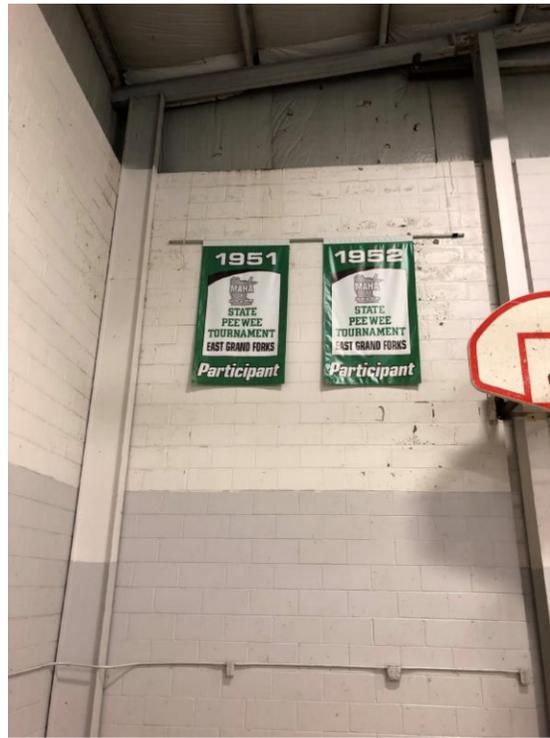
19

Note: Evidence of water leaking from roof, southeast corner. Bubbling paint caused by water vapor driving through the CMU wall.

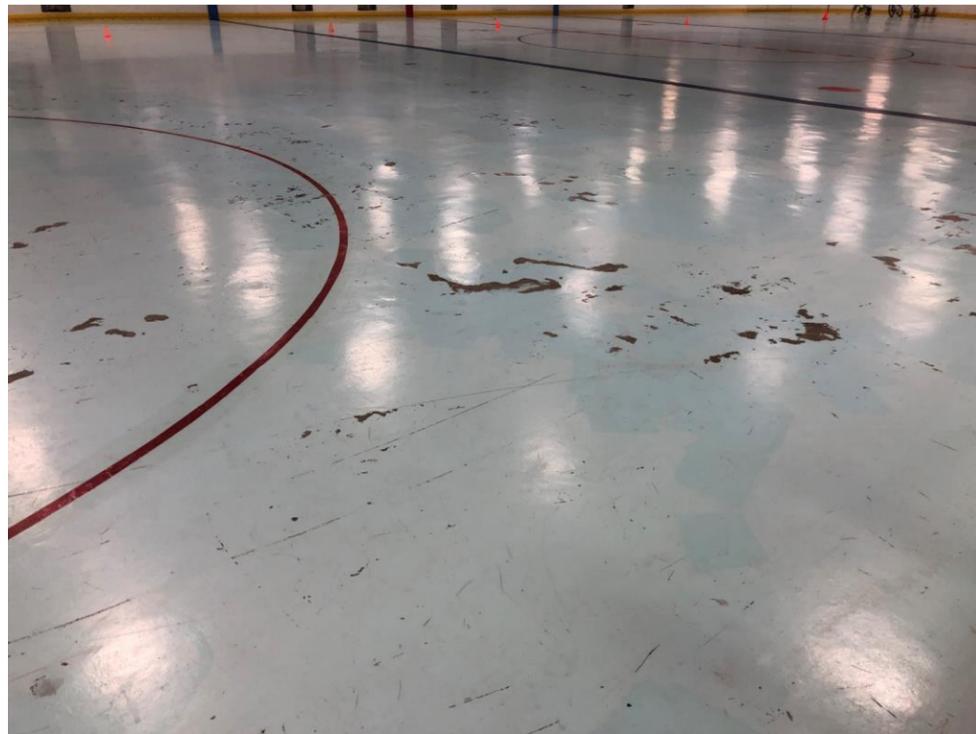
20

Note: Condition of the rink floor

5. Replace the ice rink floor. The ice rink floor has exceeded its life expectancy but is not showing signs of failure and has reportedly been working well. The replacement of the rink floor could take a place at a later date.

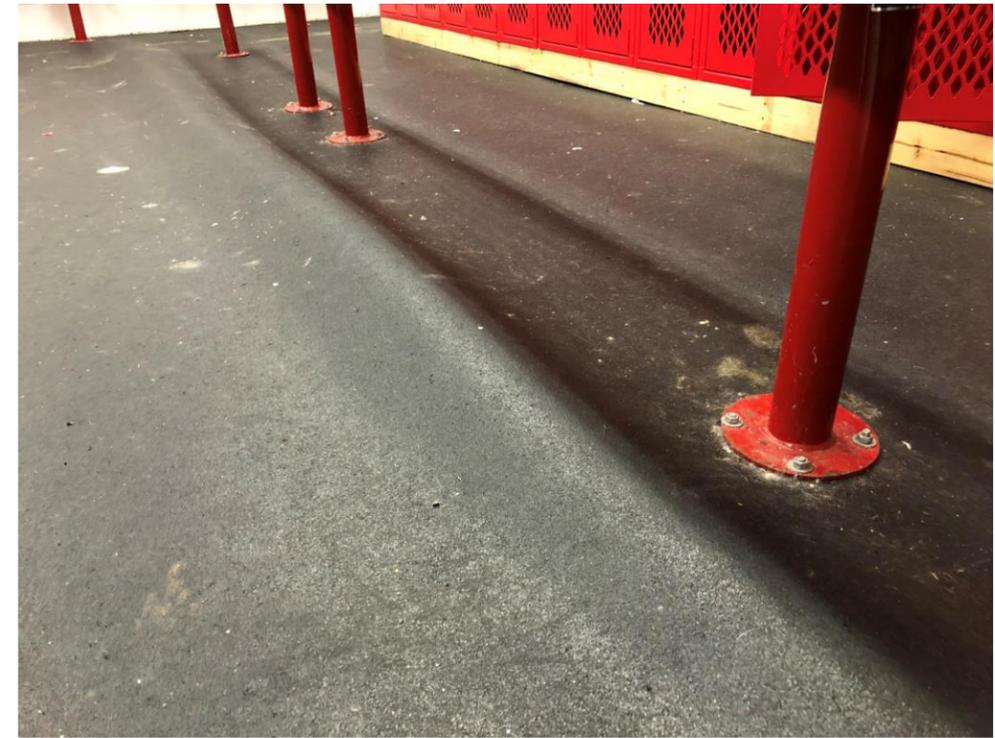
21

Note: Bubbled flooring in locker rooms is a trip hazard.

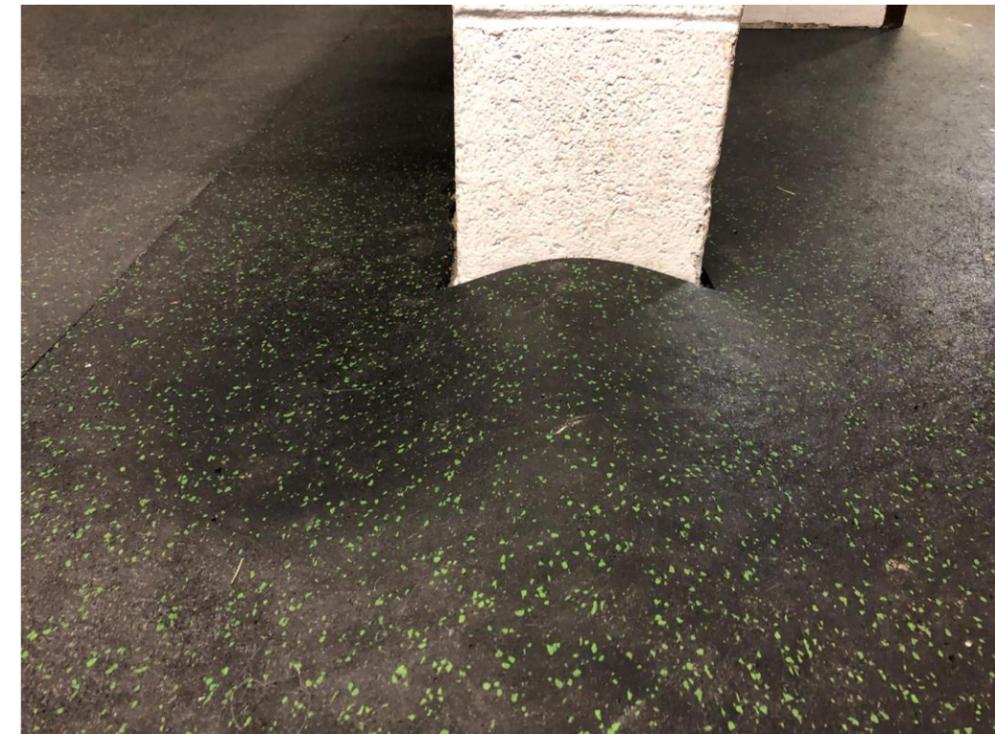
22

Note: Bubbled flooring in locker rooms is a trip hazard.

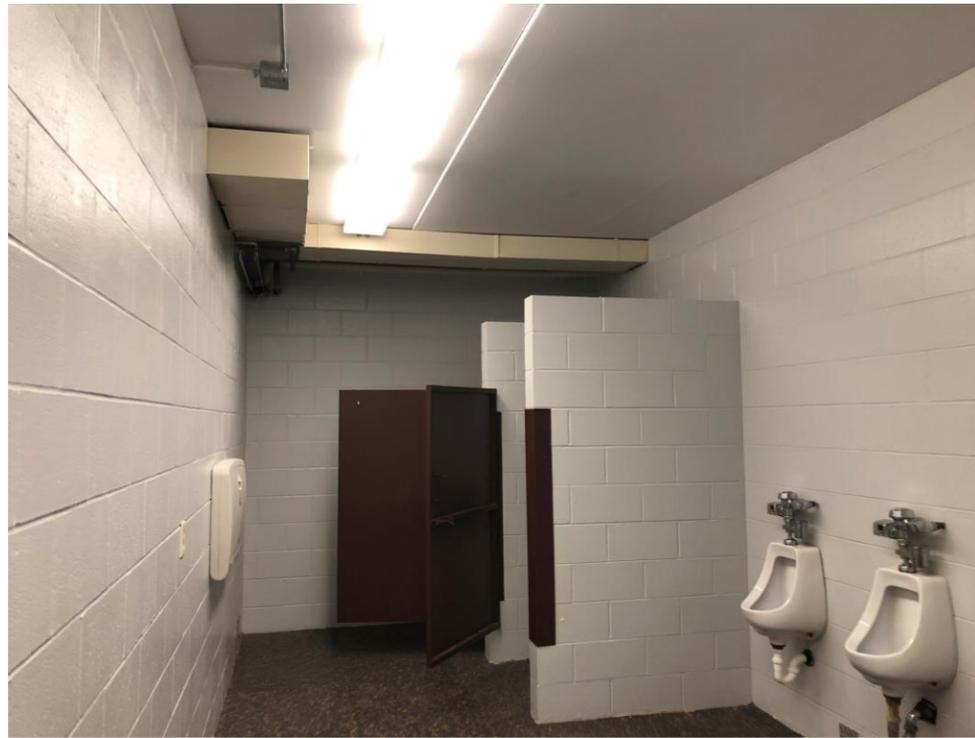
23

Note: No ADA stall or grab bars provided in restrooms. Partition doors exceed ADA maximum force requirements.

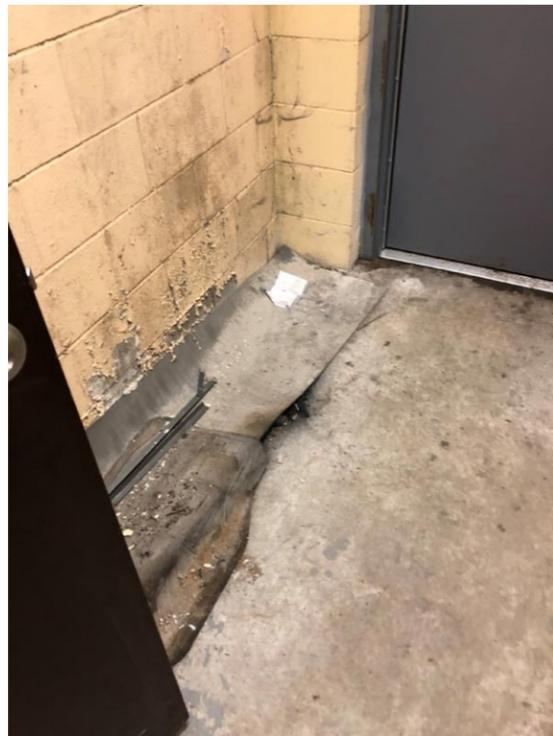
24

Note: Debris in egress stair.

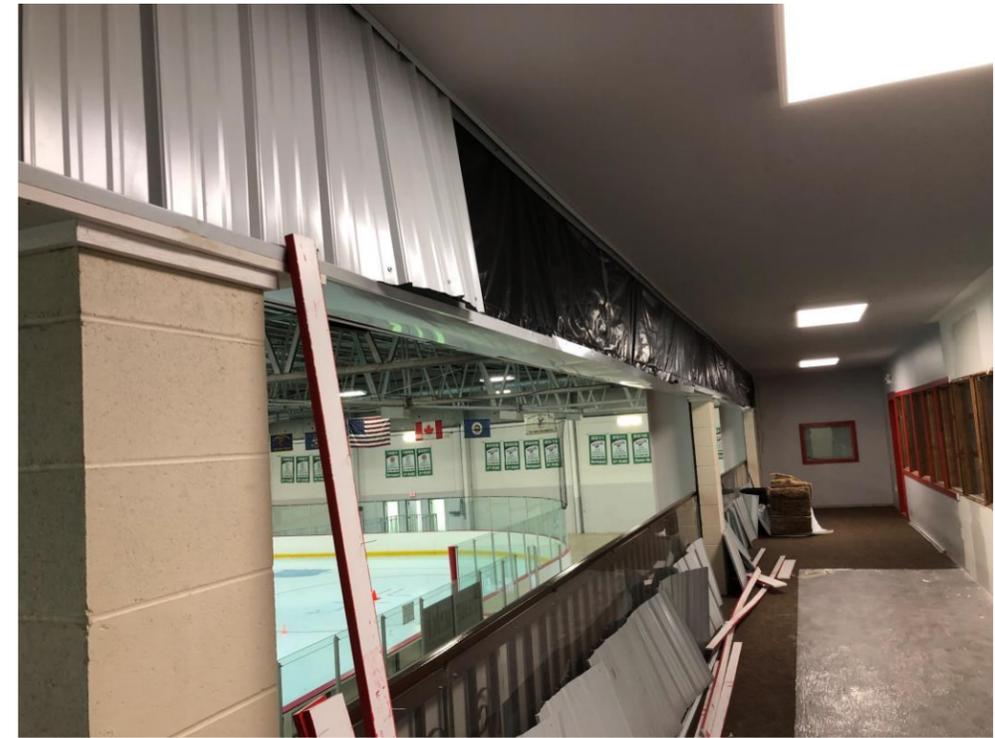
25

Note: Ongoing repairs from roof leak at Overlook.

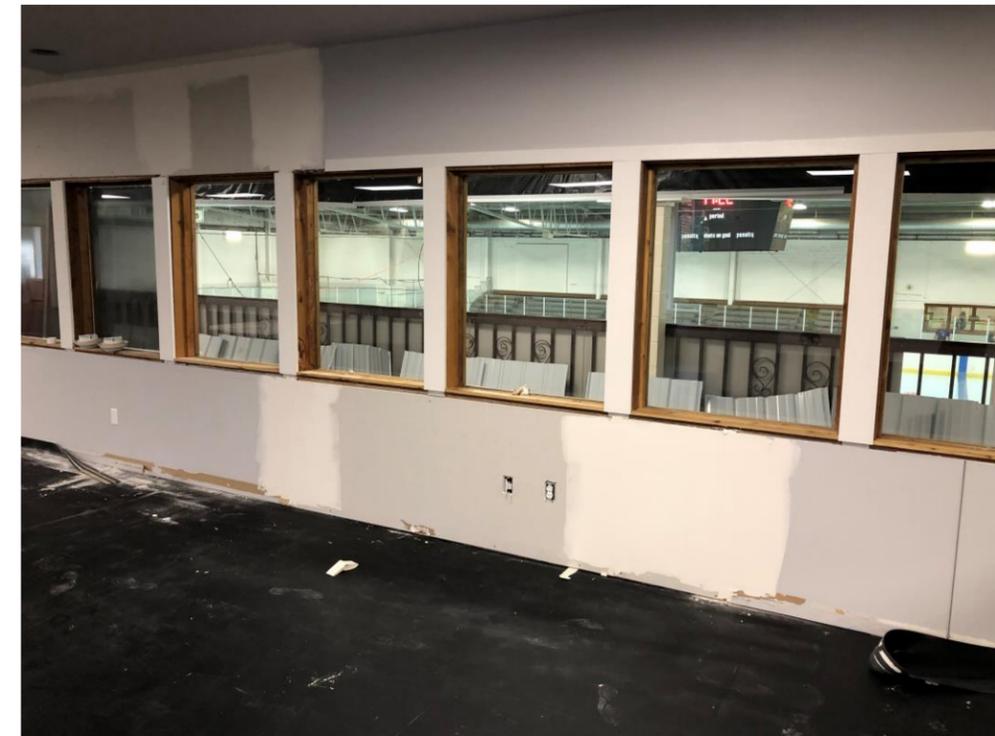
26

Note: Ongoing repairs from roof leak in Multi-Purpose/Exercise room.

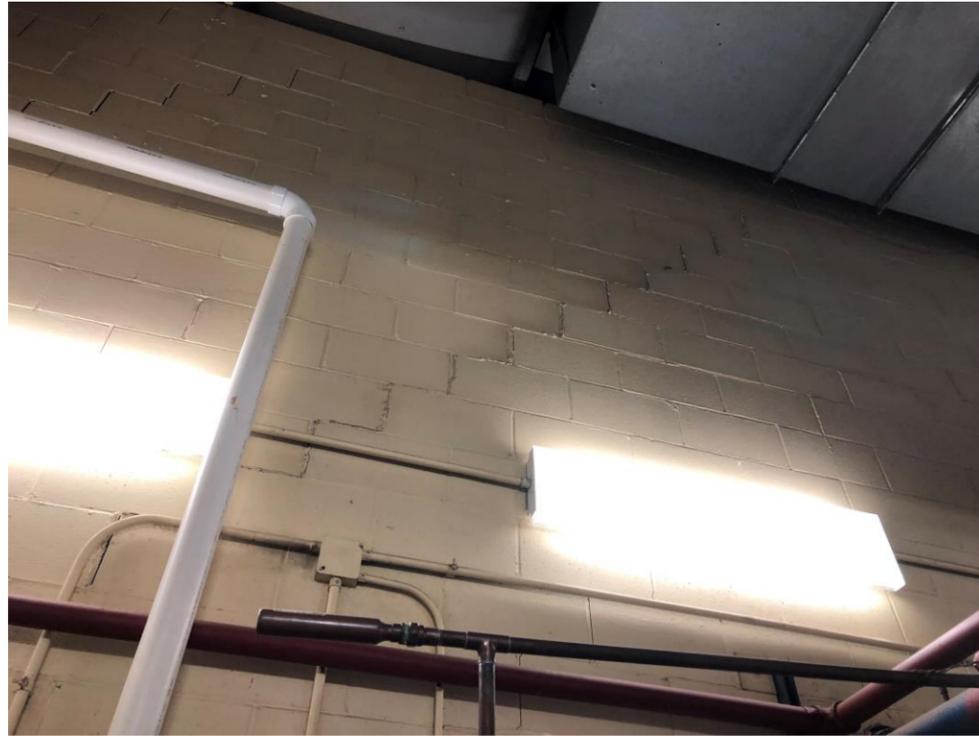
27

Note: Significant cracking in exterior wall of mechanical room, likely settling.

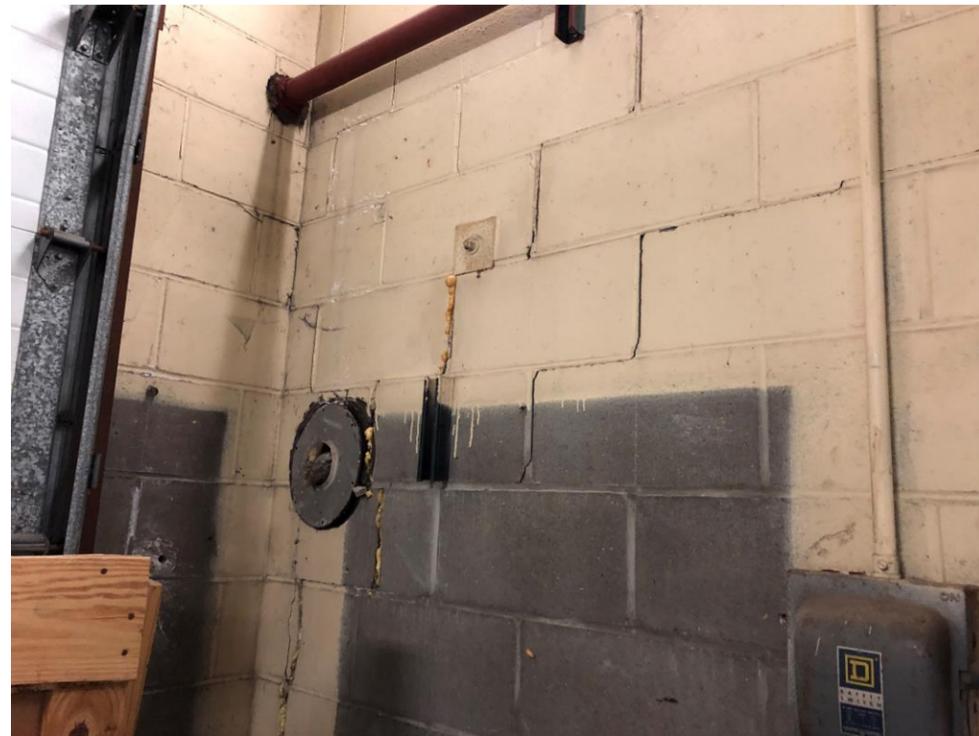
28

Note: Significant cracking in exterior wall of mechanical room, likely settling.

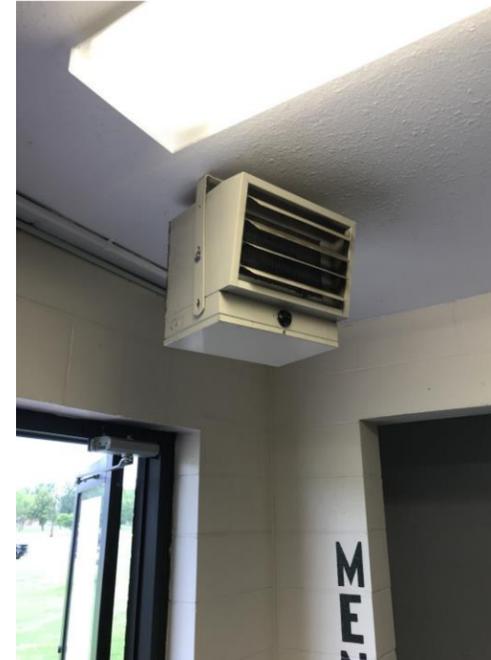
Note: Electric heat used throughout the auxiliary spaces.

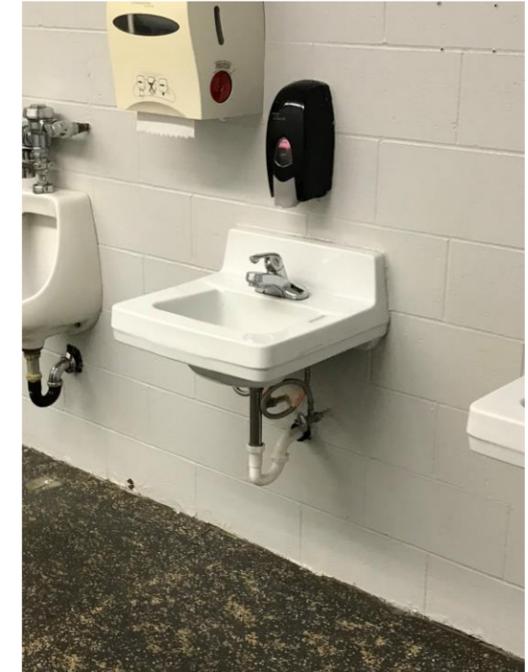
29

Note: Scald protection not provided on public lavatories.

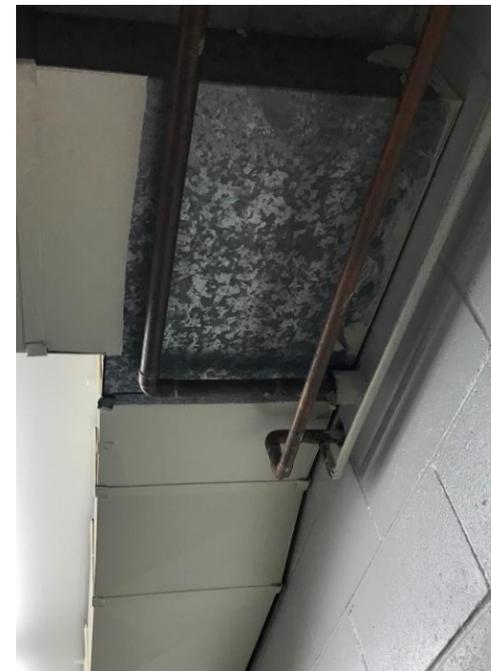
Note: Domestic water piping uninsulated throughout Locker room spaces.

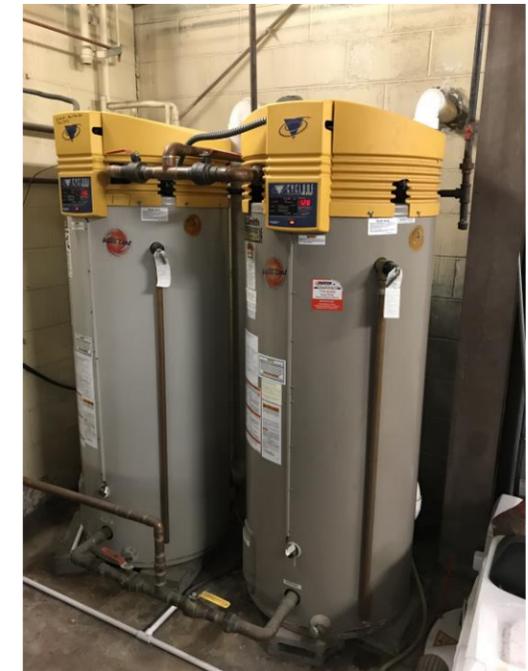
30

Note: Water Heaters installed in 2000 are at end of useful life.

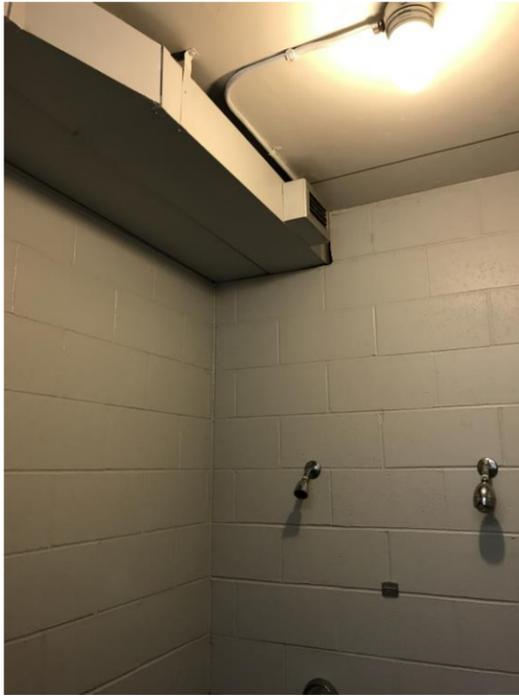
Note: Exhaust from locker rooms and no make up air provided into spaces.

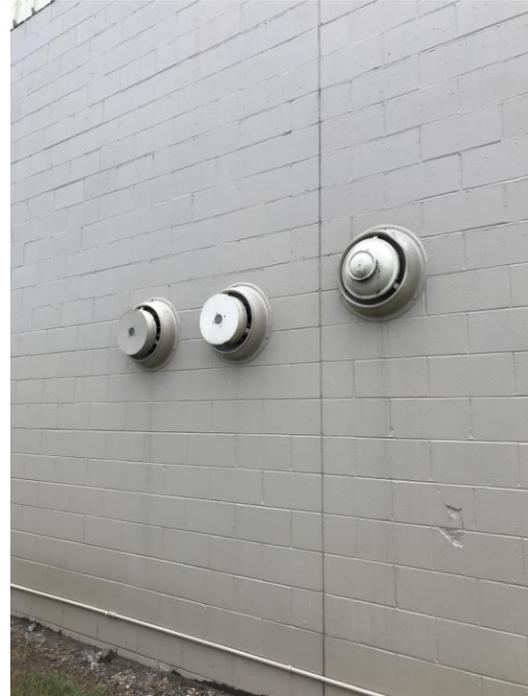
31

Note: Sidewall exhaust fans original to building.

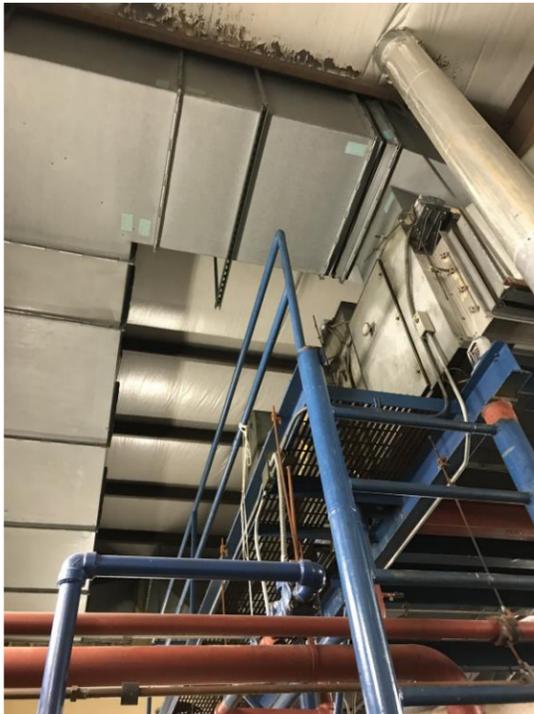
32

Note: Air handling unit serving arena. Hot water heat and no cooling.

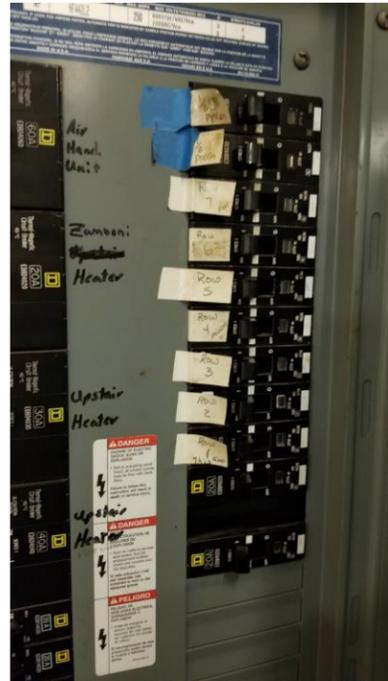
Note: Breakers used for lighting control.
